APPENDIX E

GEOTECHNICAL

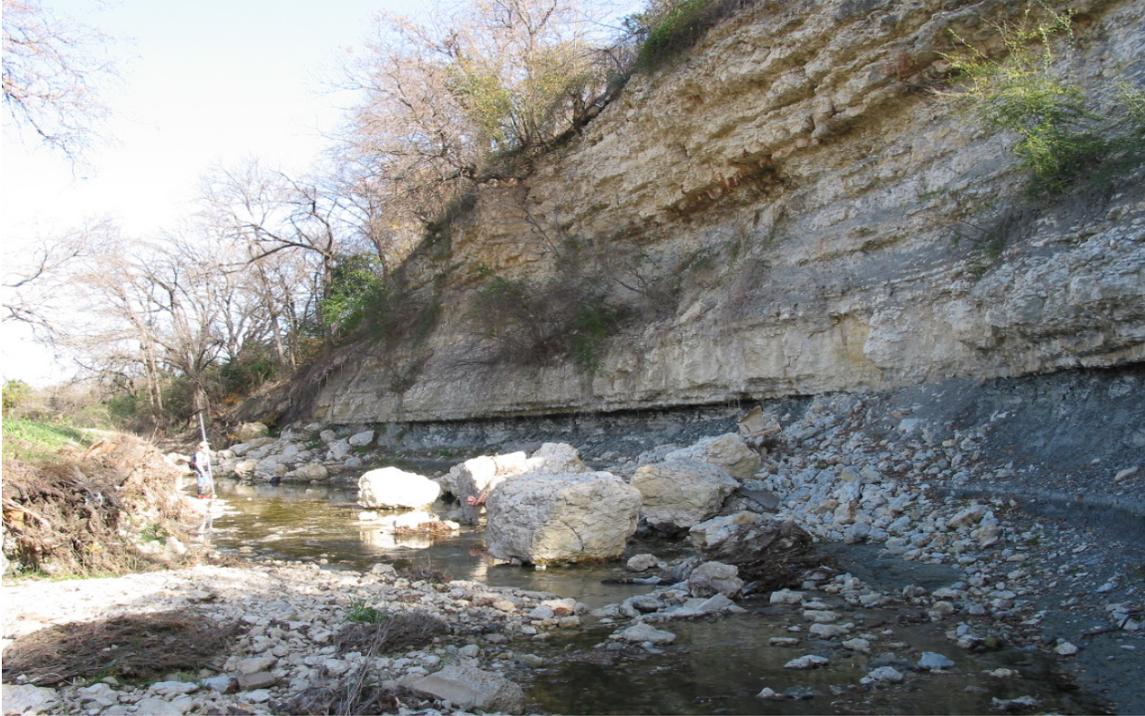
Figure 1 - Goodland Limestone Outcrop along Farmers Branch. (Station 100+00).

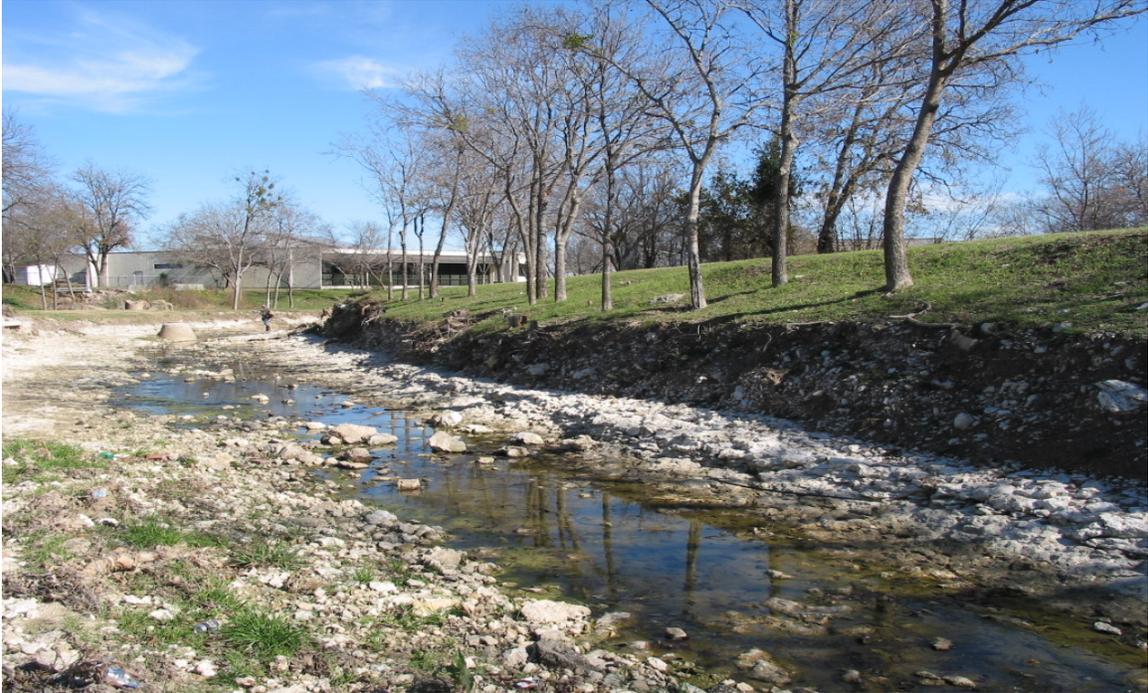
Figure 2 - Typical Cross-section of Farmers Branch. The channel bottom is cut into the Goodland Formation limestone. The channel banks consist of limestone and overlying alluvium. Alluvial materials consist of silty clay with interbedded limestone gravel and sands.
