**PECAN CREEK, GAINESVILLE, TEXAS  
DETAILED PROJECT REPORT  
AND INTEGRATED ENVIRONMENTAL ASSESSMENT**

**APPENDIX E  
CULTURAL RESOURCES**

**PECAN CREEK FLOOD REDUCTION PLAN FORMATION AND POTENTIAL IMPACTS TO  
ARCHITECTURAL AND ENGINEERING CULTURAL RESOURCES WITHIN THE AREA OF  
POTENTIAL EFFECT**

**Project:** Pecan Creek, Gainesville, Texas (PWI No. 176240)

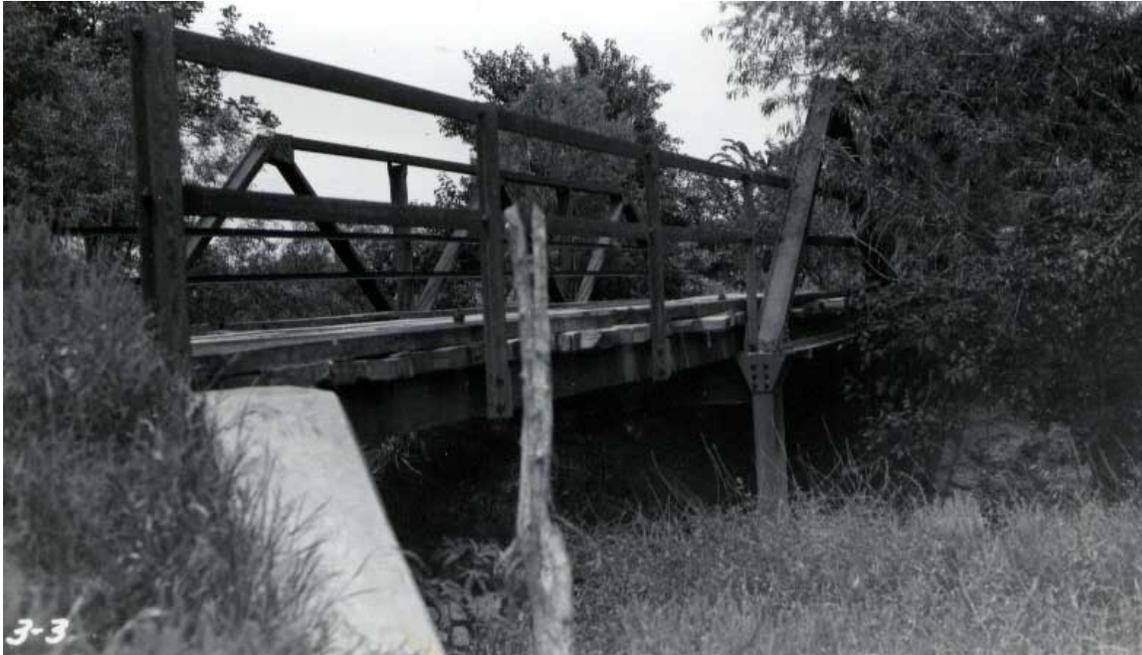
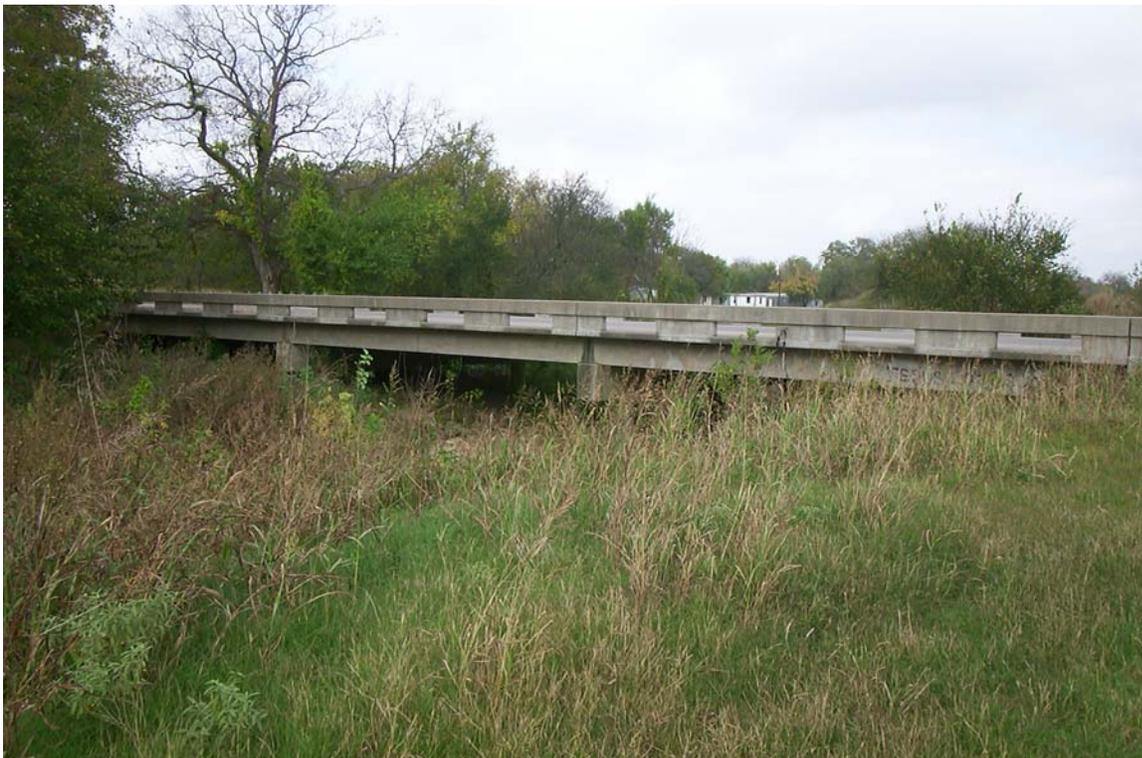
- **Anthony Street Bridge.** (Figures 2 and 3) The bridge is less than fifty years of age, and does not meet Criterion G for exceptional significance for properties less than fifty years of age. It is **not eligible** for the NRHP.

**Figure 2. Anthony Street Bridge (1948).**

**Figure 3. Anthony Street Bridge Looking North, Beginning of Lower Reach (2003).**

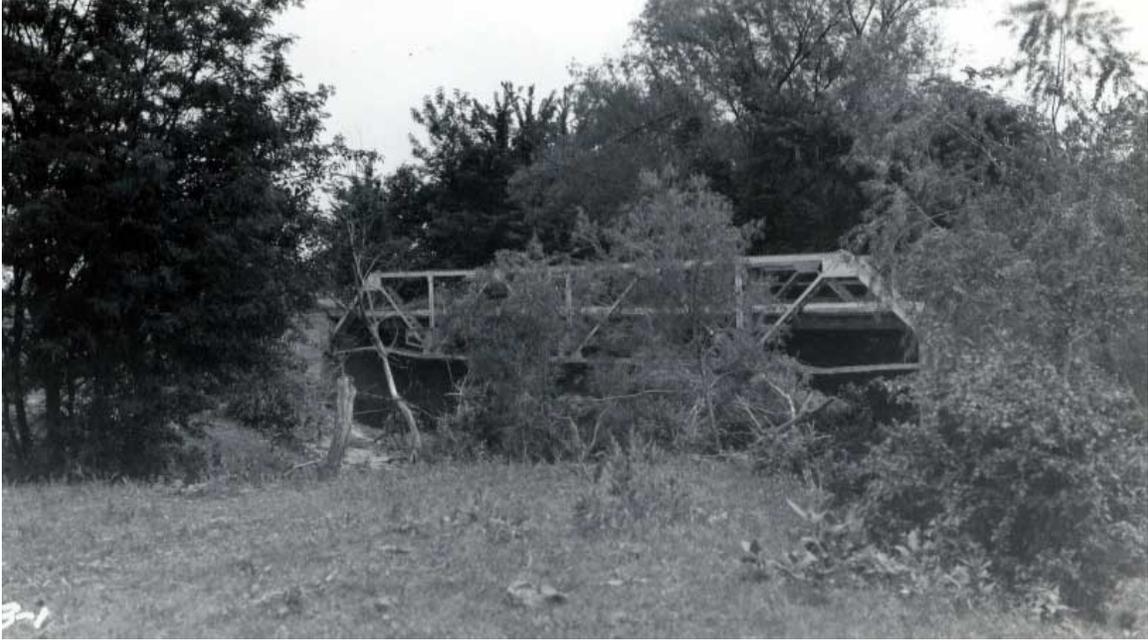
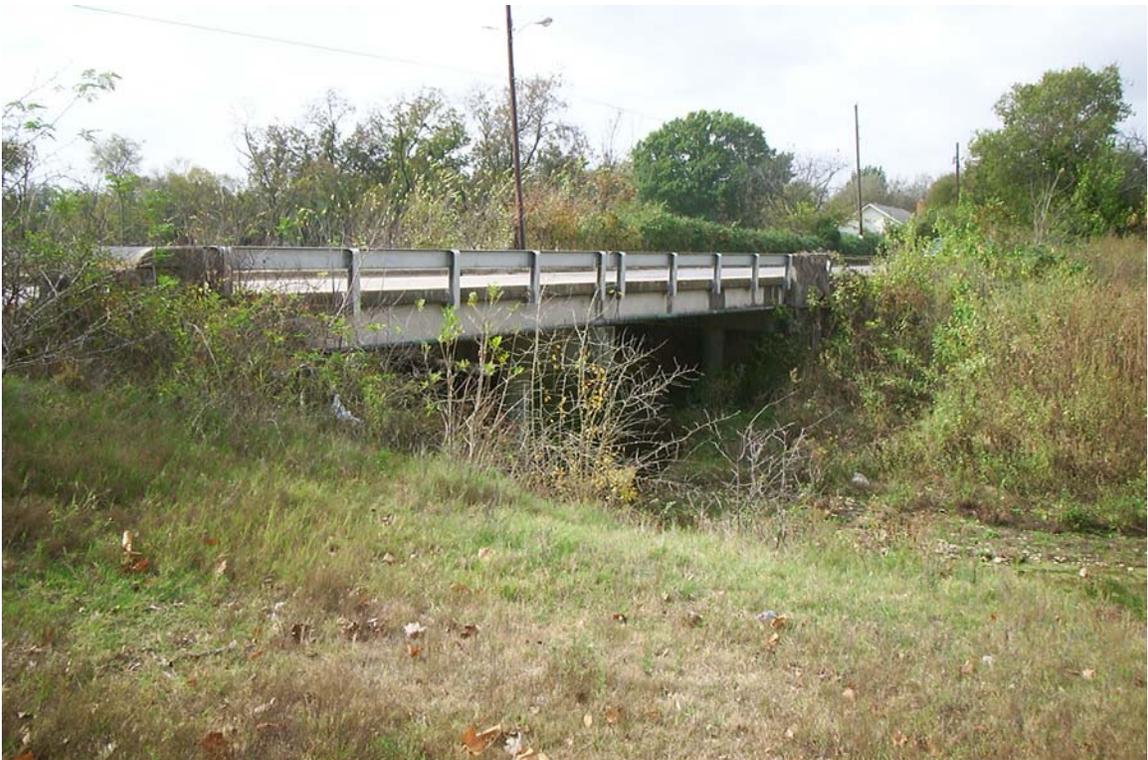
- **Moss Street Bridge.** (Figures 4 and 5) The bridge is less than fifty years of age, and does not meet Criterion G for exceptional significance for properties less than fifty years of age. It is **not eligible** for the NRHP.

**Figure 4. Moss Street Bridge (1948).**

**Figure 5. Moss Street Bridge Looking South (2003).**

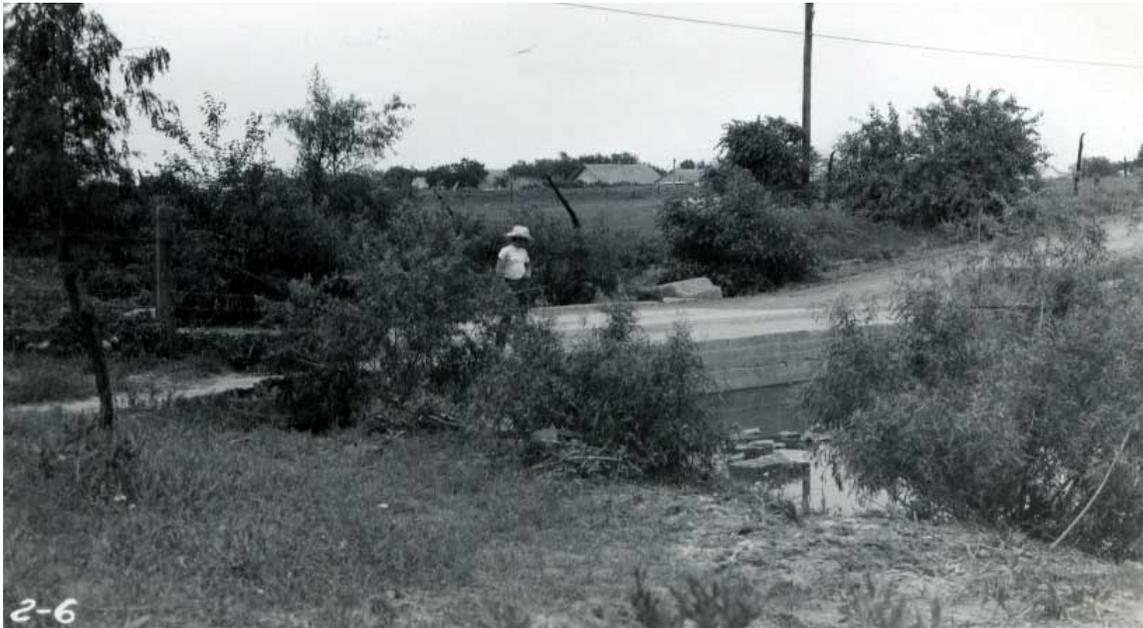
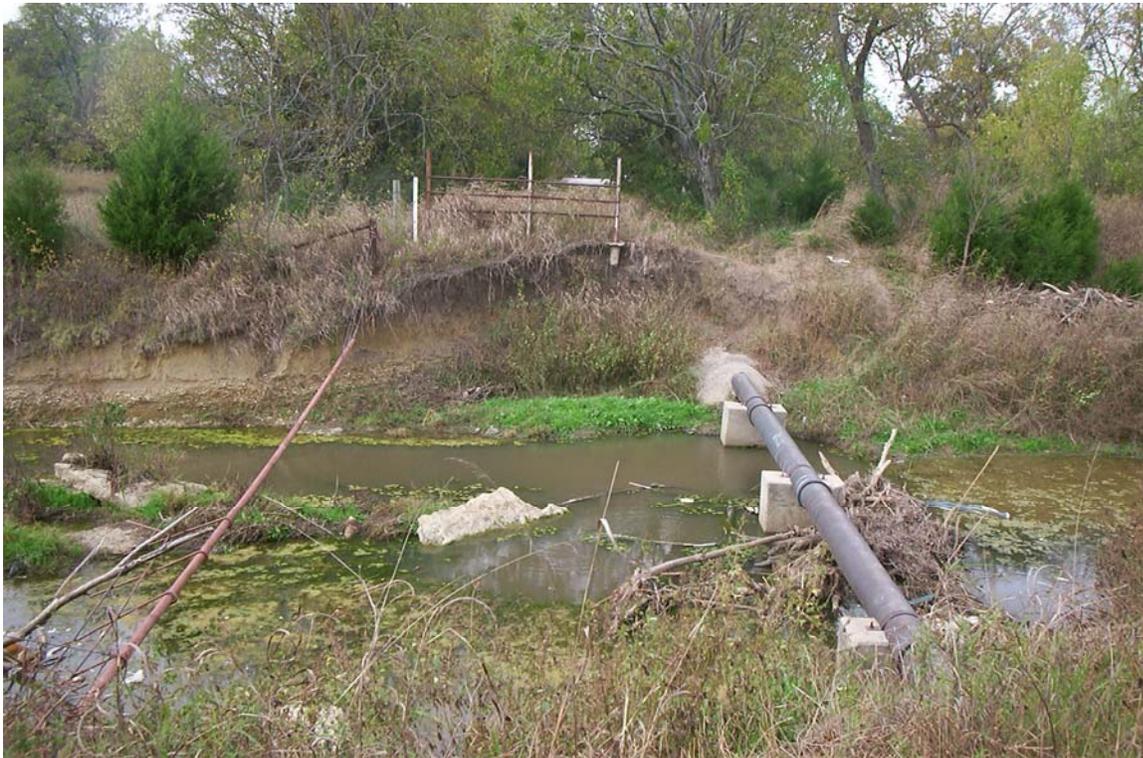
- **Gordon Street Water Crossing.** (Figures 6 and 7) The water crossing has been demolished and is no longer extant. It is **not eligible** for the NRHP.

**Figure 6. Gordon Street Water Crossing (1948).**

**Figure 7. Former Gordon Street Water Crossing (2003).**

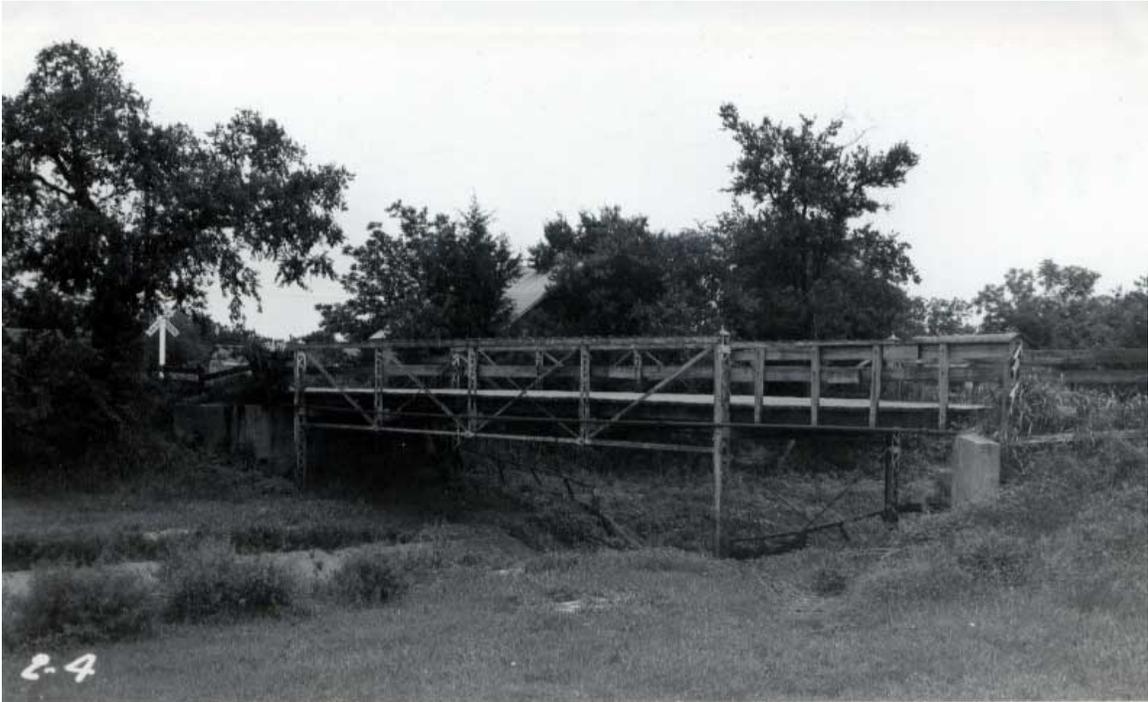
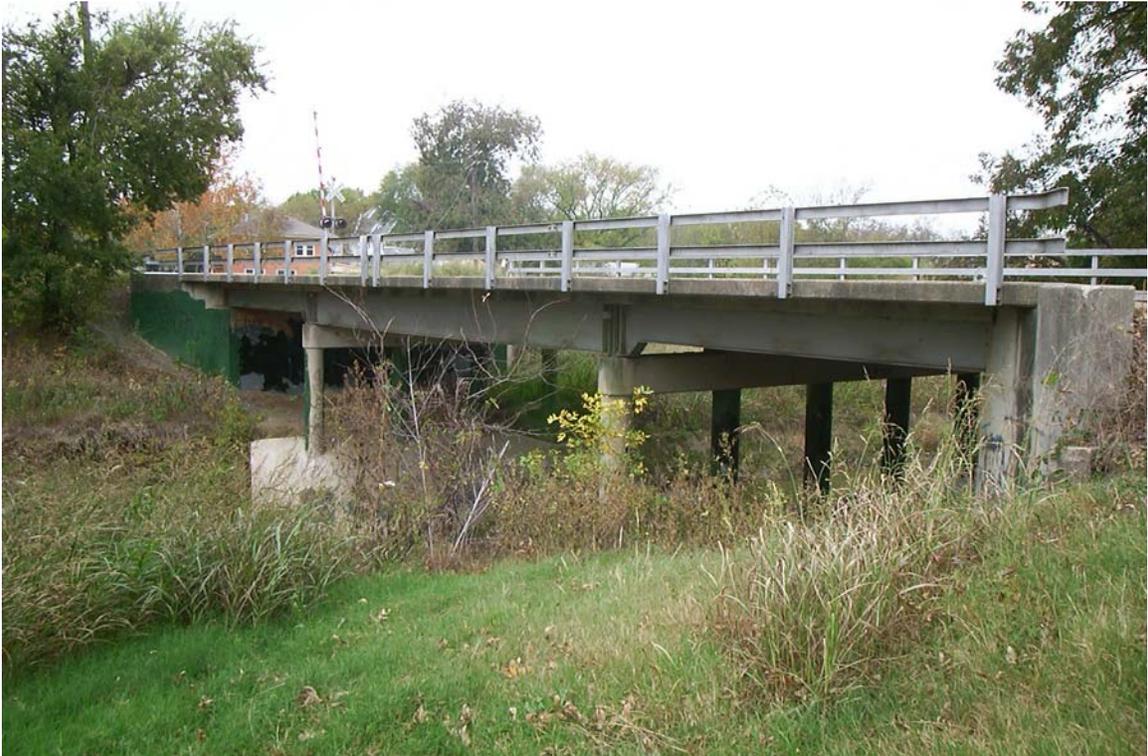
- **Garnett Street Bridge.** (Figures 8 and 9) The bridge is less than fifty years of age, and does not meet Criterion G for exceptional significance for properties less than fifty years of age. It is **not eligible** for the NRHP.

**Figure 8. Garnett Street Bridge (1948).**

**Figure 9. Garnett Street Bridge Looking North (2003).**

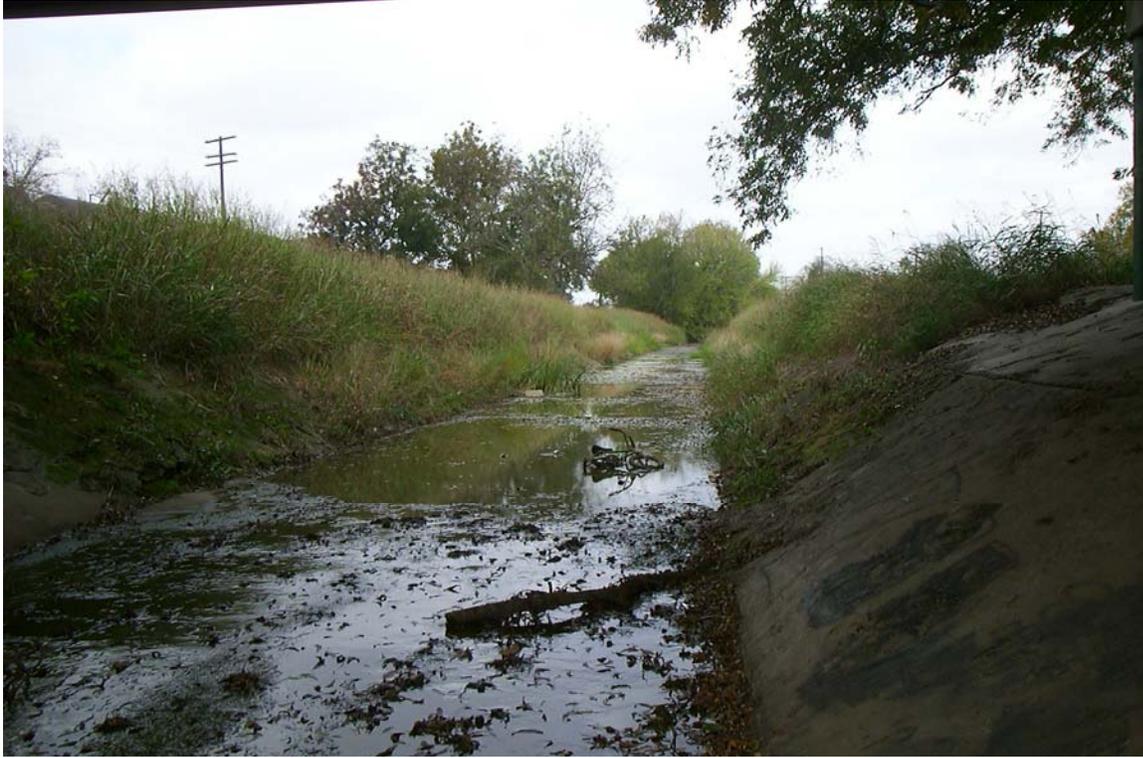
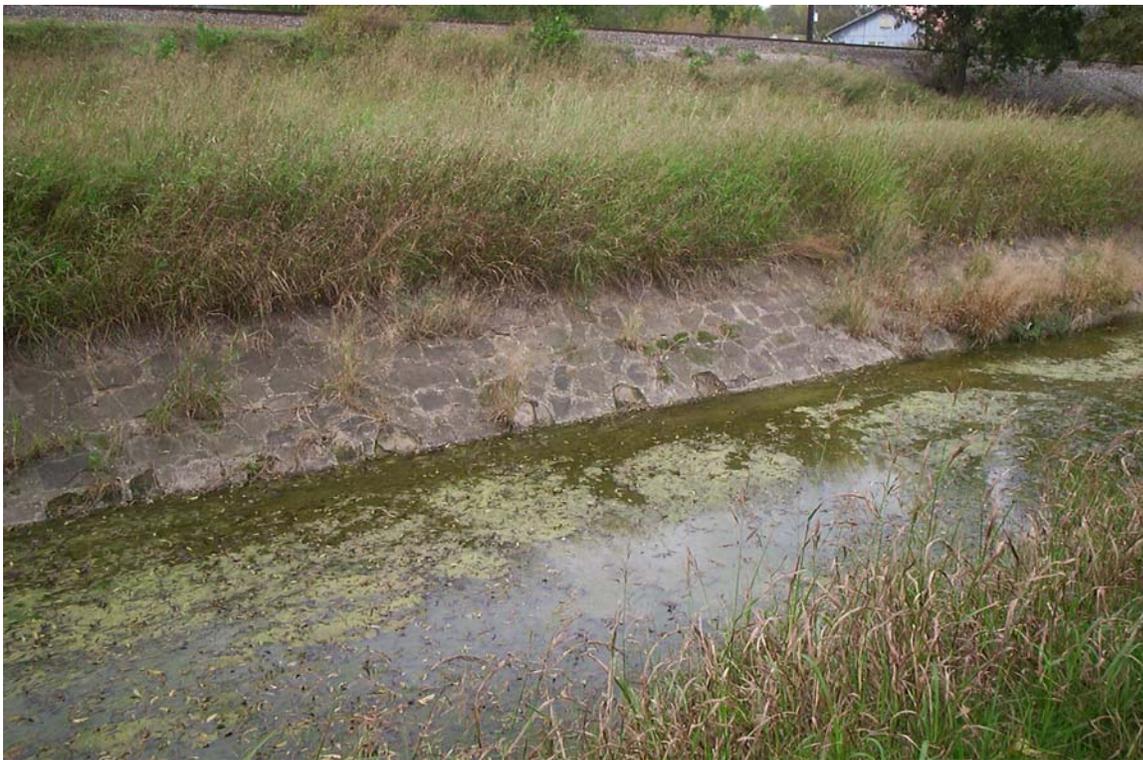
- **Rock Lined Drainage Channel.** (Figures 10, 11, 24, 25) Pecan Creek has been channelized on its course through the downtown section Gainesville since the early part of the twentieth century. During the 1930s, the Civilian Conservation Corps completed a lining of the channel with flagstone that. The flagstone channel is approximately 26 feet wide at the top, 14 feet wide at the bottom and 3.5 feet deep. The rock lining has been removed in several stretches and replaced by concrete. An estimated 50% of the channel is original construction. The remaining original construction retains a high degree of integrity as evidenced by comparison with the 1948 photographs. As a true representative example as a depression era public works project, the rock lined channel is **eligible** for the NRHP for its design and construction values and its association with the event of the Great Depression and its related large public works projects designed to provide work for unemployed Americans.

**Figure 10. Beginning of Rock Lined Channel at Garnett Street Bridge (2003).**

**Figure 11. Rock Lined Channel (2003).**

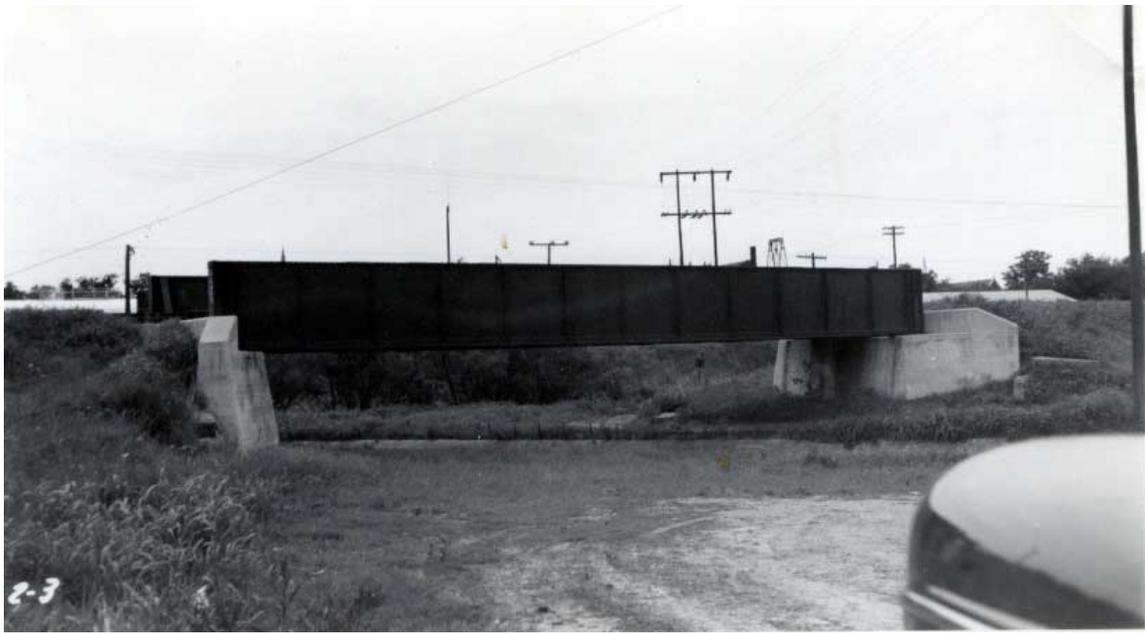
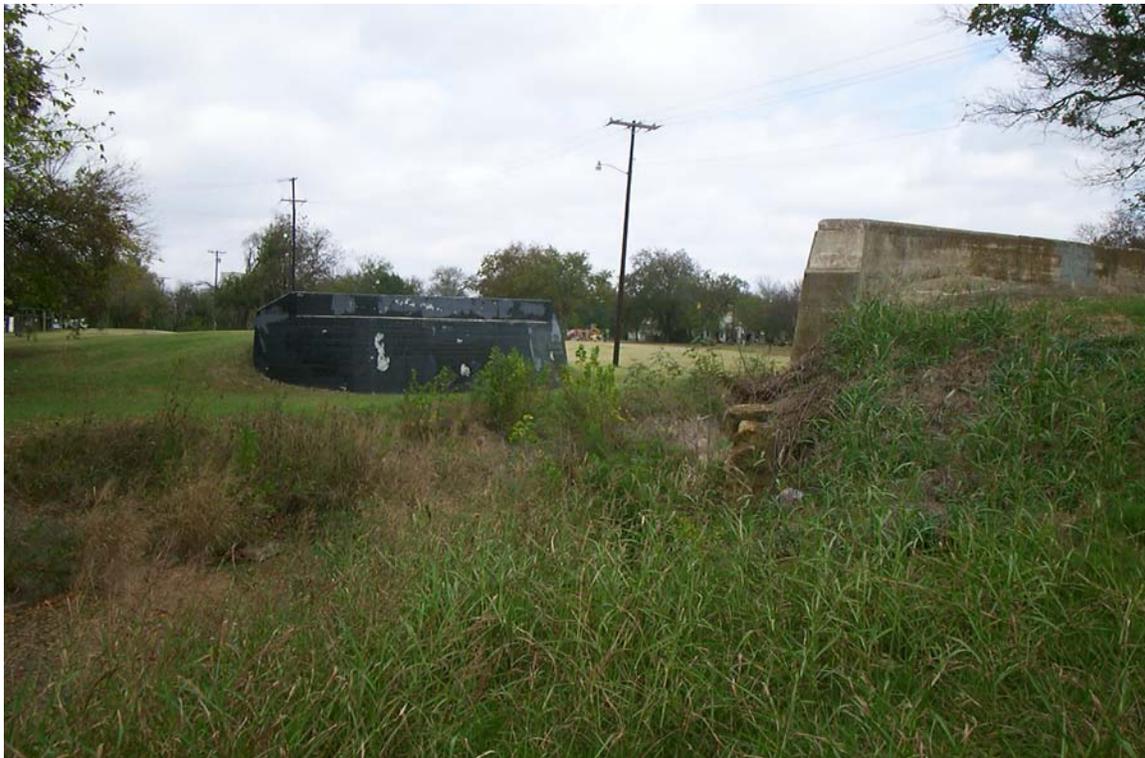
- **MKT Railroad Trestle.** (Figures 12 and 13) Constructed 1937. The right of way has been abandoned by the railroad and has been transformed into a pedestrian trail. The tracks and the roadbed leading to trestle have been removed and only the concrete abutments remain. The integrity of materials has been reduced to a point to which the trestle no longer conveys its significance as a local example of early-to-mid twentieth century Texas railroad construction. It is **not eligible** for the NRHP.

**Figure 12. MKT Railroad Trestle (1948).**

**Figure 13. 1937 Railroad Abutment (2003).**

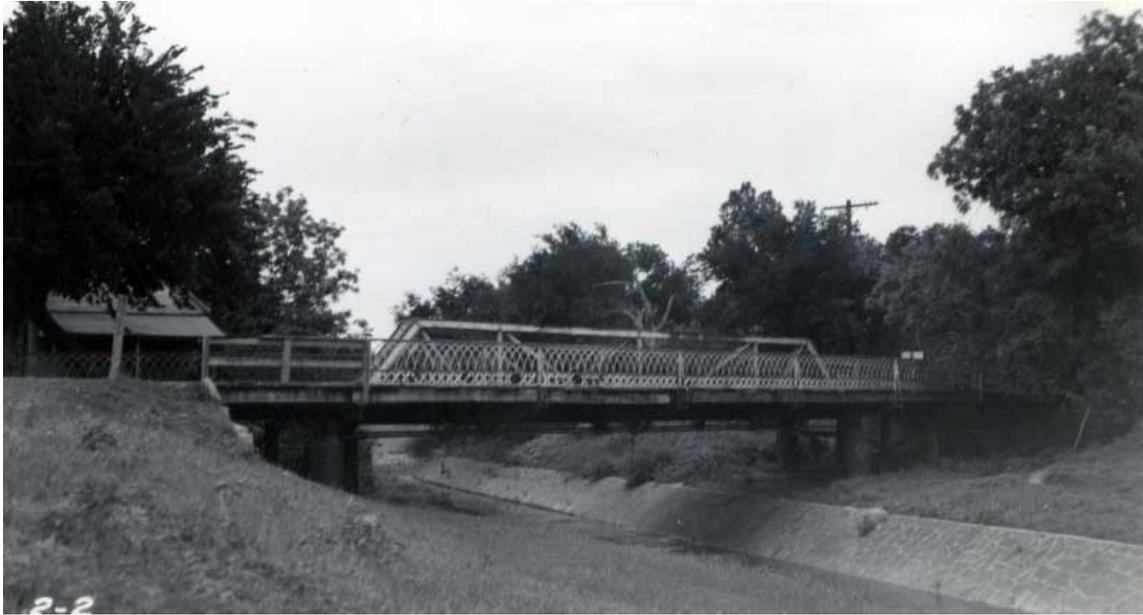
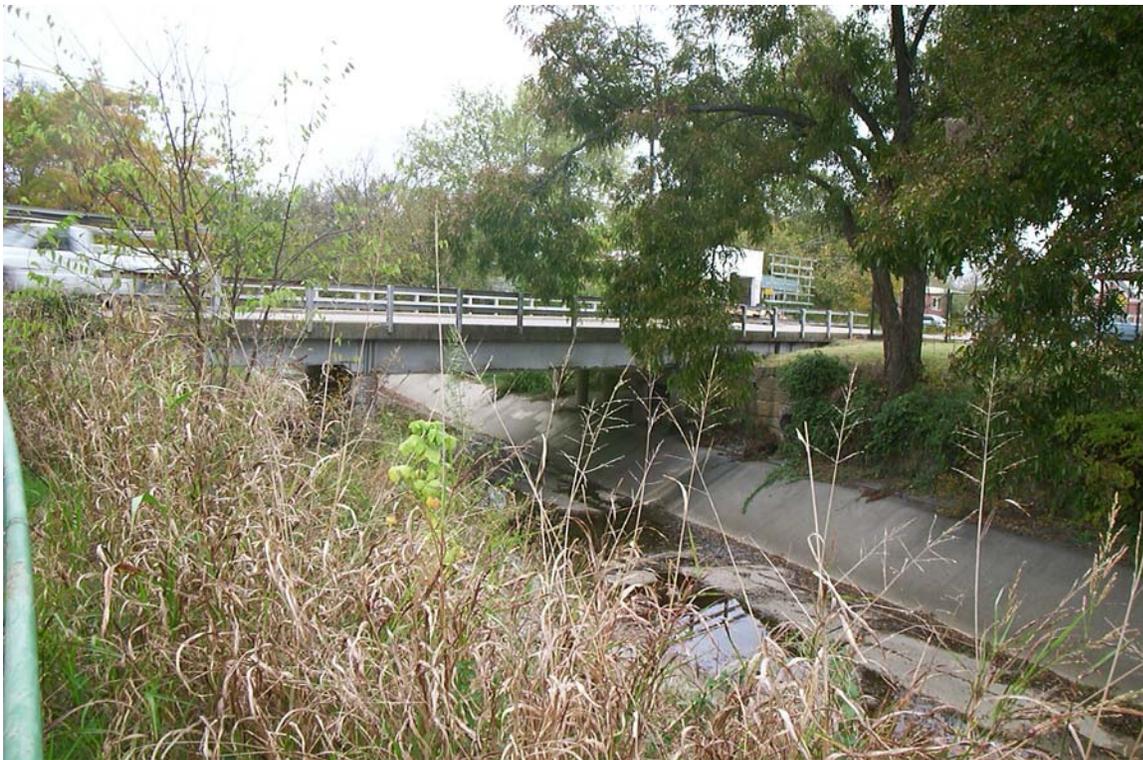
- **Main Street Bridge.** (Figures 14 and 15) The bridge is less than fifty years of age, and does not meet Criterion G for exceptional significance for properties less than fifty years of age. It is **not eligible** for the NRHP.

**Figure 14. Main Street Bridge (1948).**

**Figure 15. Main Street Bridge (2003).**

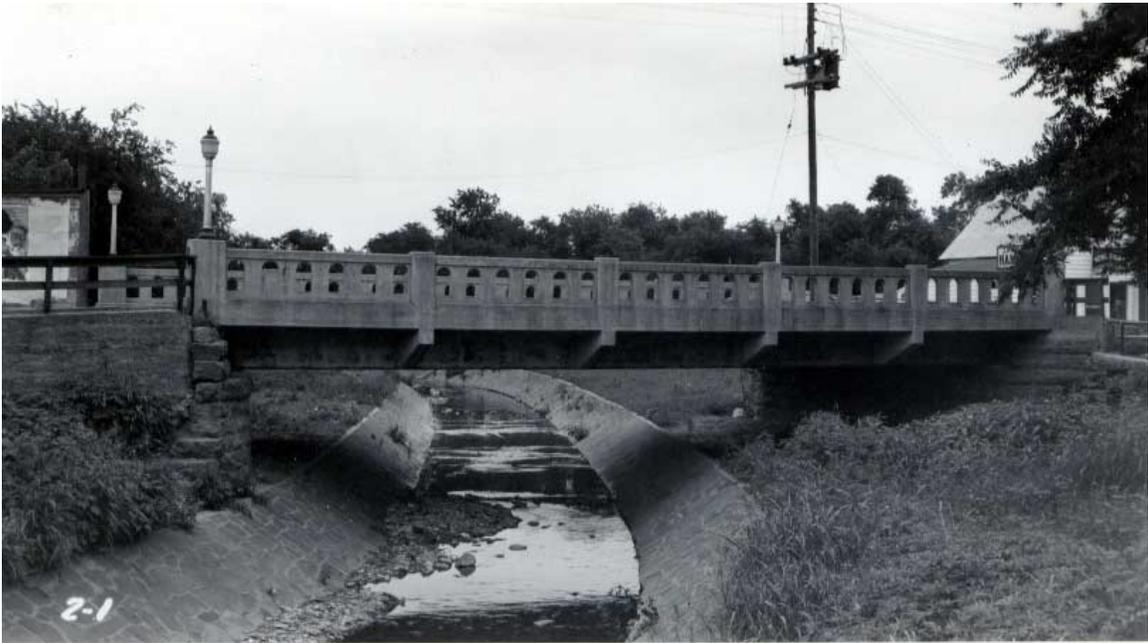
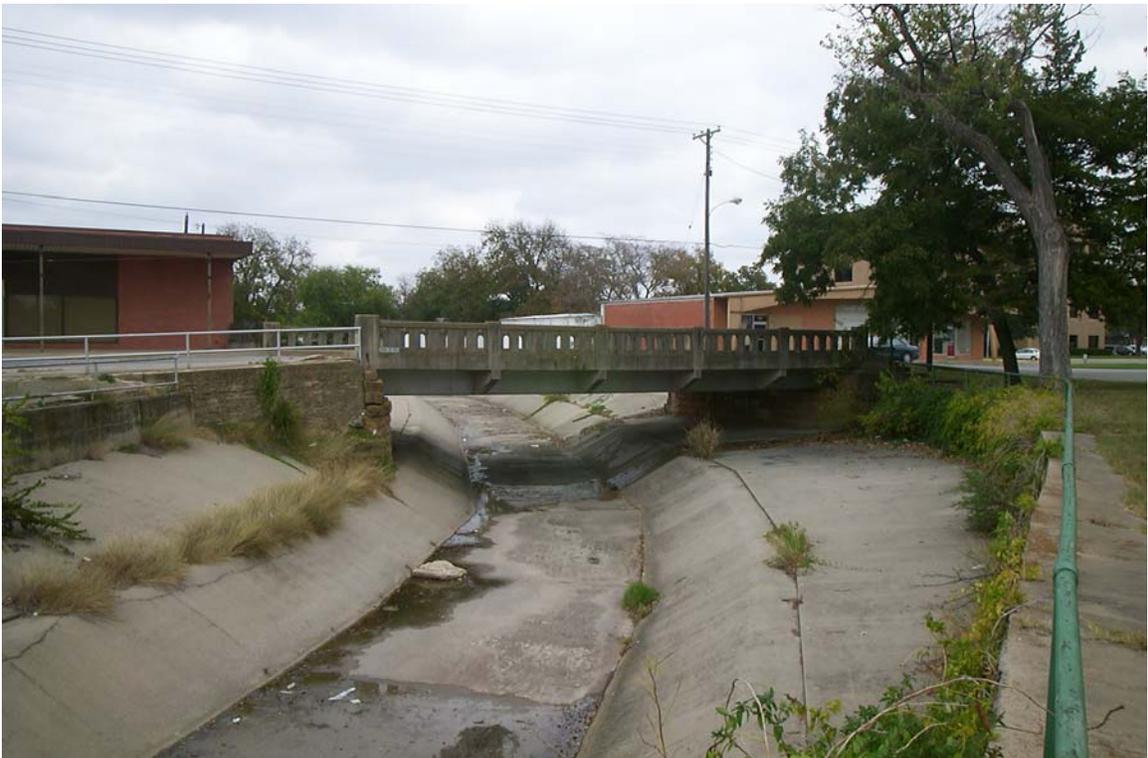
- **California Street Bridge.** (Figures 16, 17, 18 and 19) The bridge, built in 1935, is a primary crossing point for vehicular traffic in and out of downtown Gainesville. The structure is built of reinforced concrete. It retains a very high degree of integrity in both materials and workmanship. Only the original lampposts have been removed. While the concrete has spalled in several areas due to water penetration of the steel reinforcement, the bridge is structurally sound and viable for continued use. It is **eligible** for the NRHP on a local level for its construction values as a true representative example of early twentieth-century vehicular bridge.

**Figure 16. California Street Bridge (1948).**

**Figure 17. California Street Bridge (2003).**

Urban development of the city did not embrace the waterway and initially appears to be an obstacle to development rather than an asset. This is probably due to the frequent flooding of the area and is probably responsible for the lack of development immediately adjacent to the creek. The main section of the waterway was channelized in the 1930s by the Civilian Conservation Corps as Pecan creek runs through the center of town. Commercial buildings that line the creek turn their back to the waterway, with no access or development made to enhance this natural feature (Figure 18). Photographs illustrate that essential feeling of Pecan Creek has remained unchanged since the Corps took pictures as part of its study in May of 1948 (Figures 16, 17, 24 & 25).

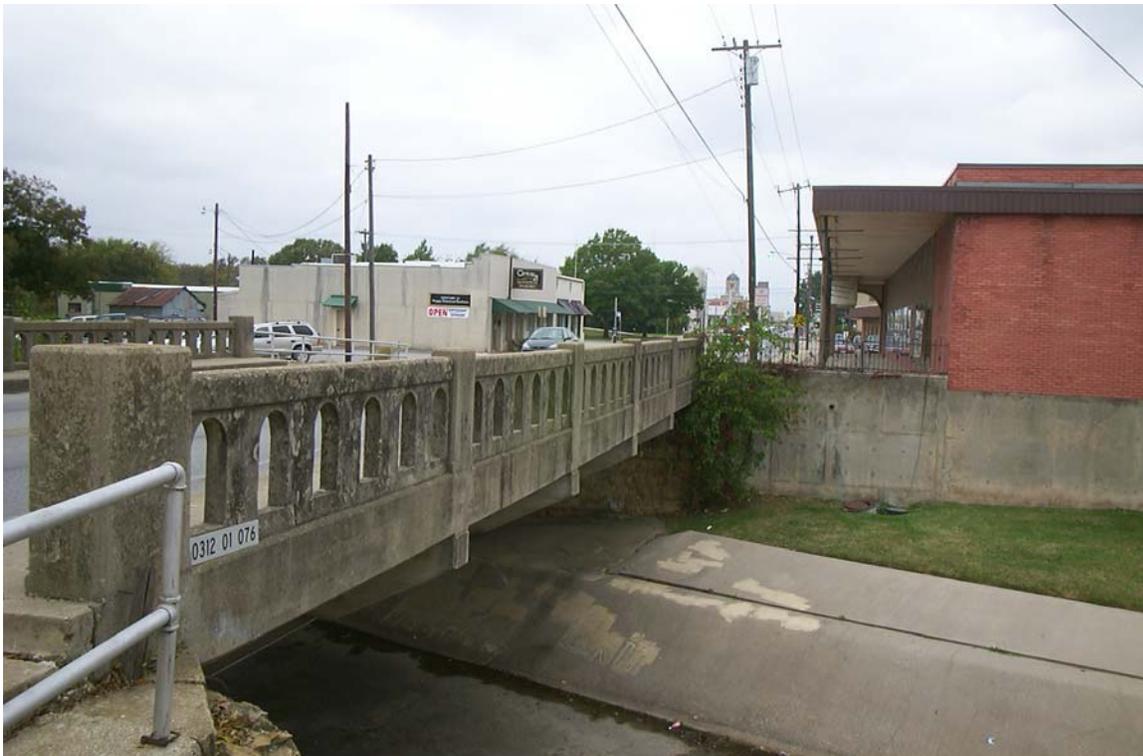
**Figure 19. California Street Bridge Looking West Toward Downtown (2003).**

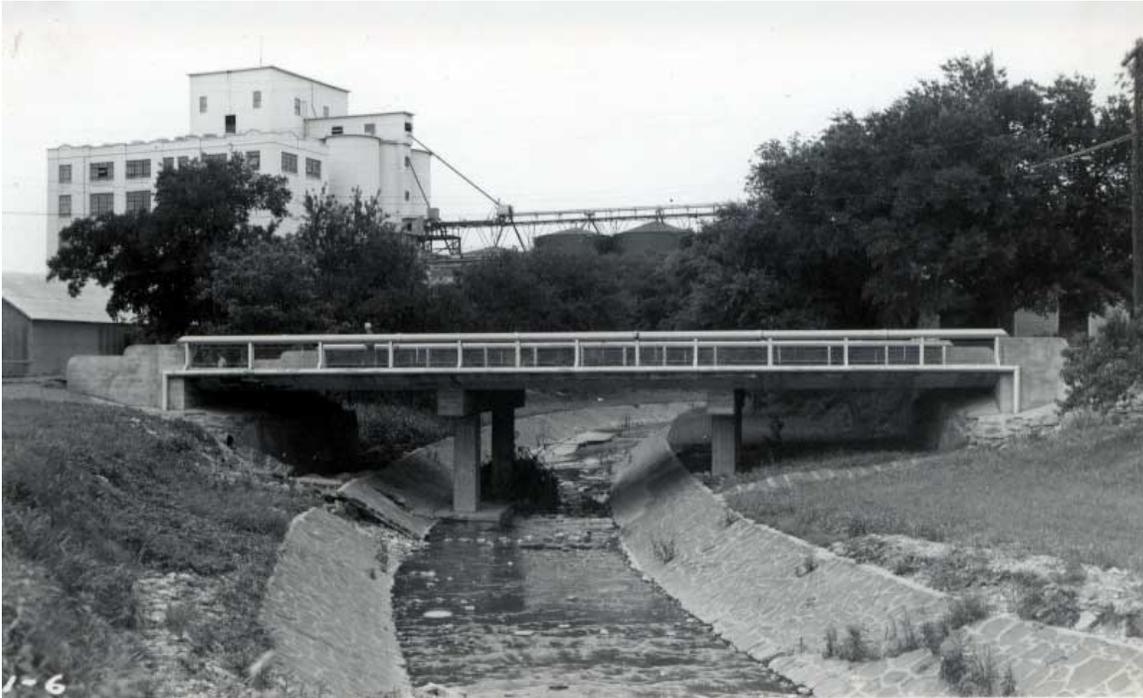
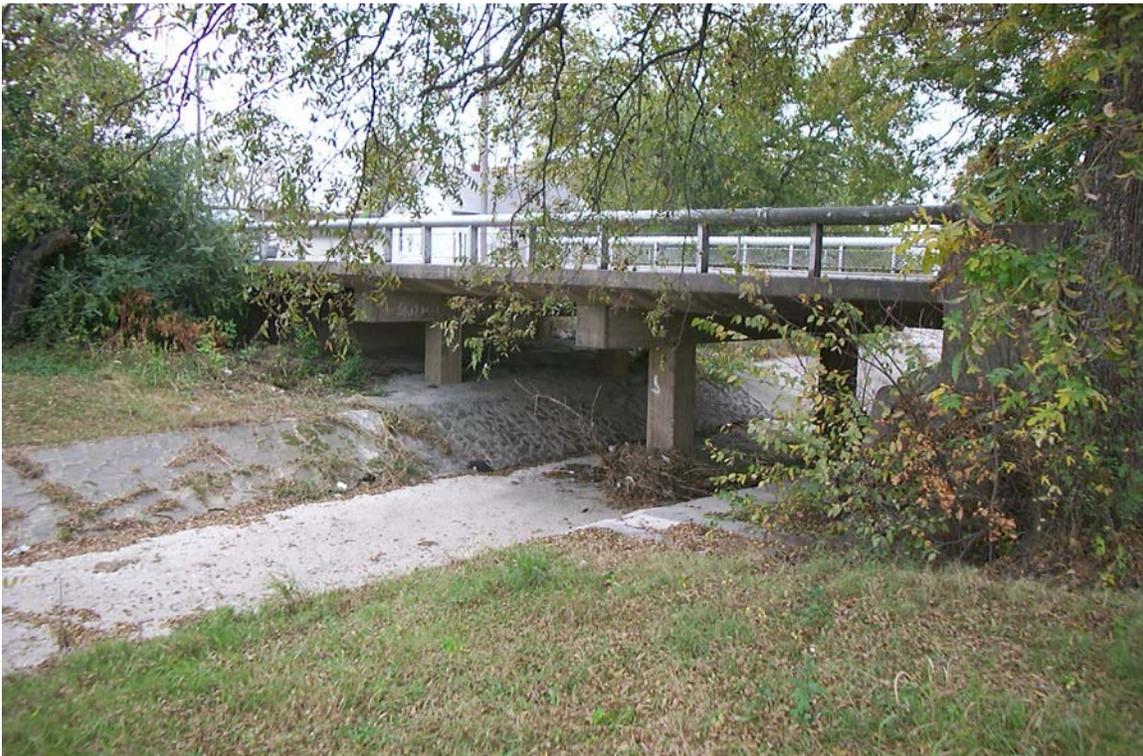
- **Broadway Street Bridge.** (Figures 20 and 21) Three span reinforced concrete flat plate construction with steel guardrails. Exact date of construction has not been determined, but the bridge was probably constructed post WWII (46-48) and is clearly over fifty years of age by its presence in the 1948 photograph. Steel shortages during the war make pre-1946 construction unlikely. The bridge matches the design of the Belcher Street Bridge and both were probably constructed concurrently. The bridge retains a high degree of integrity in both materials and workmanship. However, the bridge is not a distinctive example of a particular type, period or style of construction and is **not eligible** for the National Register under Criterion C for its design and construction values.

- **Whaley Mill & Grain Elevator.** (Seen in Figures 18 and 20) Texas Historic Sites Atlas # NRS79-0758. Located immediately adjacent to Pecan Creek on the west bank between Broadway and Scott streets, the structure is a 6 story brick commercial building and grain elevator; metal industrial type windows with recessed panels in spandrels; rectangular plan; flat roof; extended brick parapet with pediment projections rising from parapet; tallest building in the city. It is **eligible** for the National Register on a local level for its association with the economic growth of Gainesville.

**Figure 20. Broadway Street Bridge (1948).**

**Figure 21. Broadway Street Bridge (2003).**

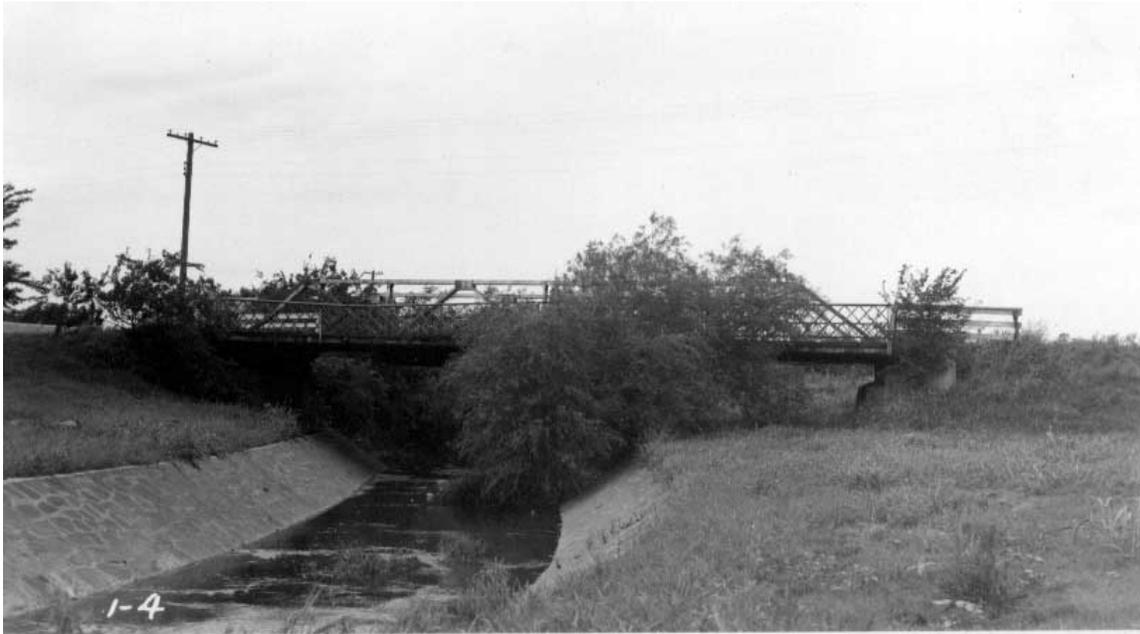
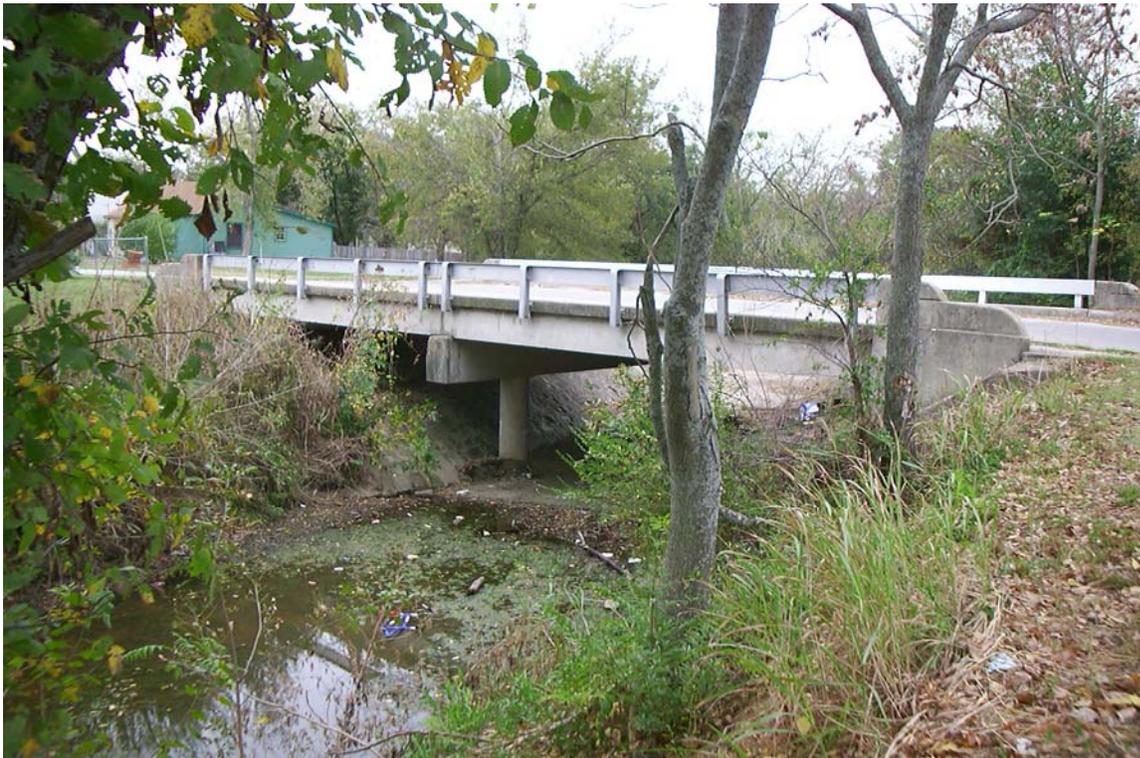
- **Scott Street Bridge.** (Figures 22 and 23). The bridge is less than fifty years of age, and does not meet Criterion G for exceptional significance for properties less than fifty years of age. It is **not eligible** for the NRHP

**Figure 22. Scott Street Bridge (1948).**

**Figure 23. Scott Street Bridge Looking South at the End of the Rock Lined Channel (2003).**

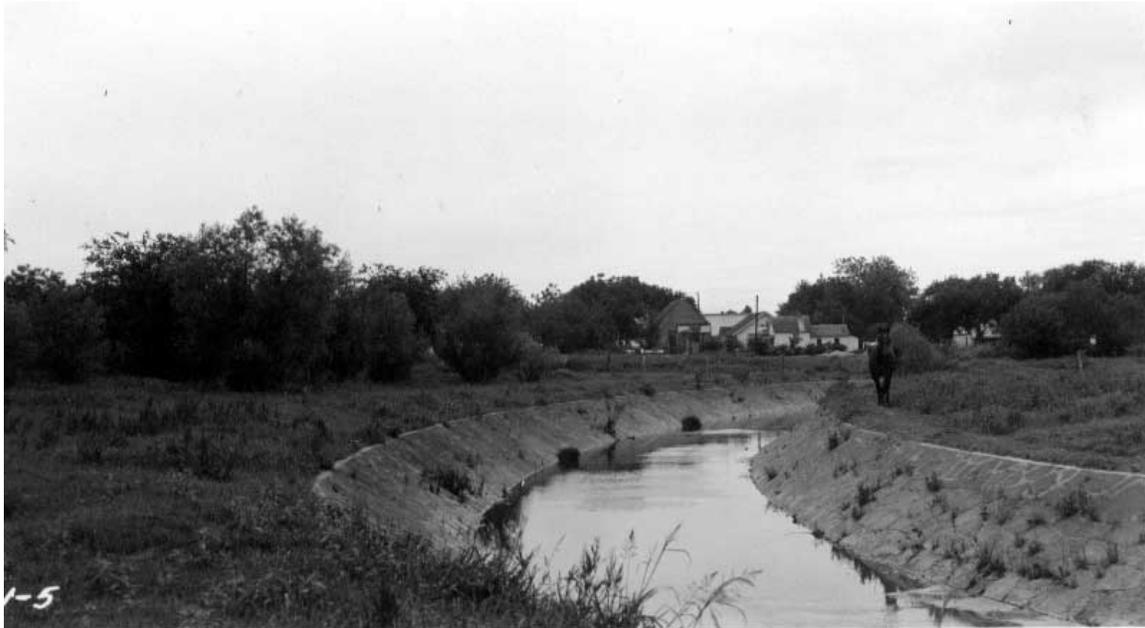
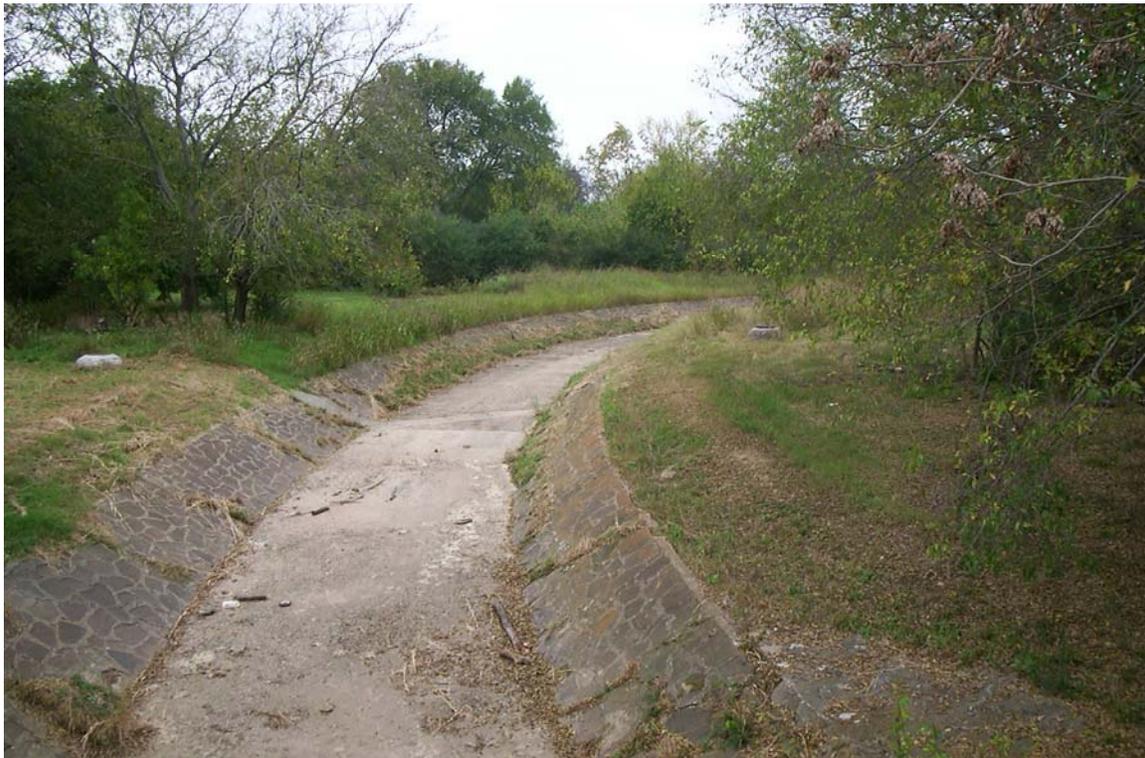
**Figure 24. Rock Lined Channel South of Scott Street (1948).**

**Figure 25. Rock Lined Channel South of Scott Street (2003).**

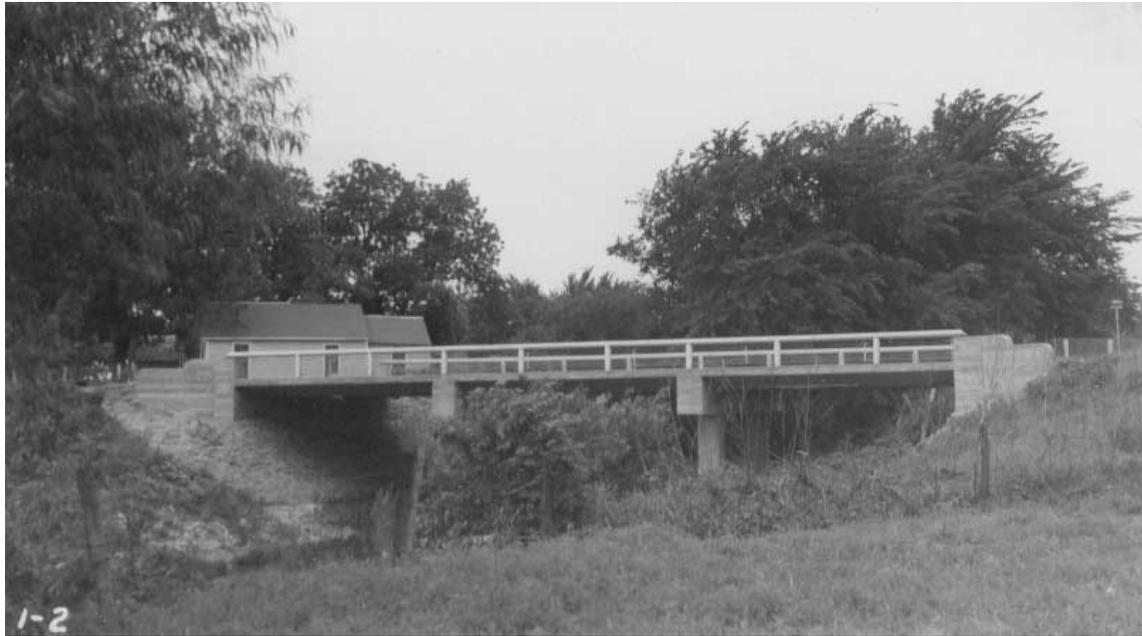
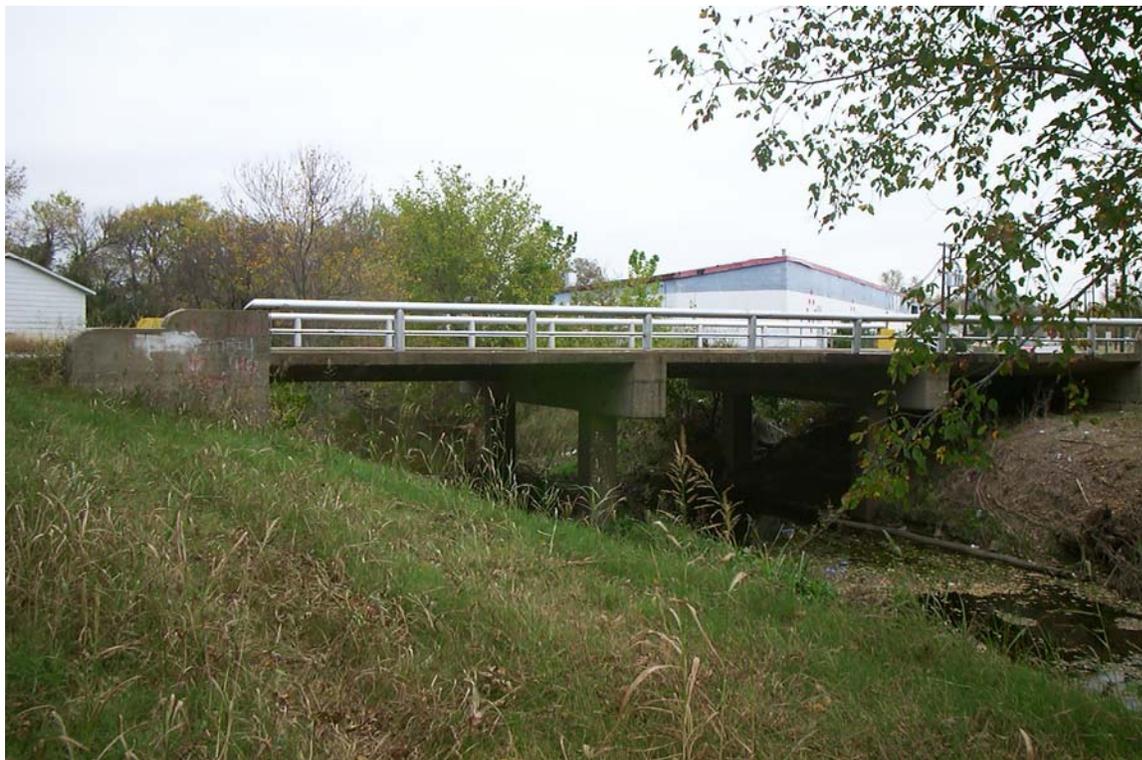
- **Belcher Street Bridge.** (Figures 26 and 27) Three span reinforced concrete flat plate construction with steel guardrails. Exact date of construction has not been determined, but the bridge was probably constructed post WWII (46-48) and is clearly over fifty years of age by its presence in the 1948 photograph. Steel shortages during the war make pre-1946 construction unlikely. The bridge matches the design of the Broadway Street Bridge and both were probably constructed concurrently. The bridge retains a high degree of integrity in both materials and workmanship. However, the bridge is not a distinctive example of a particular type, period or style of construction and is **not eligible** for the National Register under Criterion C for its design and construction values.

**Figure 26. Belcher Street Bridge (1948).**

**Figure 27. Belcher Street Bridge Looking North, Beginning of Upper Reach (2003).**
