**PECAN CREEK, GAINESVILLE, TEXAS  
DETAILED PROJECT REPORT  
AND INTEGRATED ENVIRONMENTAL ASSESSMENT**

**APPENDIX E  
CULTURAL RESOURCES**

**PECAN CREEK FLOOD REDUCTION PLAN FORMATION AND POTENTIAL IMPACTS TO  
ARCHITECTURAL AND ENGINEERING CULTURAL RESOURCES WITHIN THE AREA OF  
POTENTIAL EFFECT**

**Project:** Pecan Creek, Gainesville, Texas (PWI No. 176240)

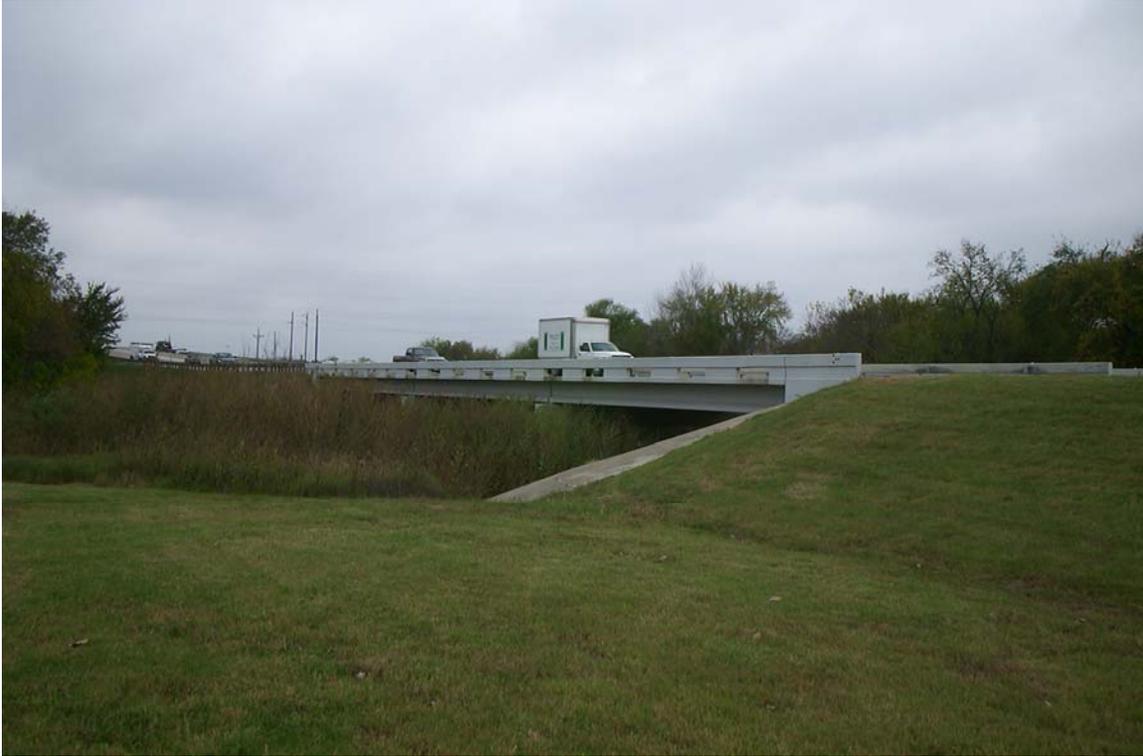
- **US HWY 82 Bridge.** (Figure 28) Built in 1990, the bridge is less than fifty years of age, and does not meet Criterion G for exceptional significance for properties less than fifty years of age. It is **not eligible** for the NRHP.

**Figure 28. US HWY 82 Bridge, Limit of Upper Reach (2003).**
