LIMITED PHASE I ENVIRONMENTAL SITE ASSESSMENT

**PARK AND MISSION REACHES
SAN ANTONIO RIVER GENERAL RE-EVALUATION STUDY
SAN ANTONIO, TEXAS**

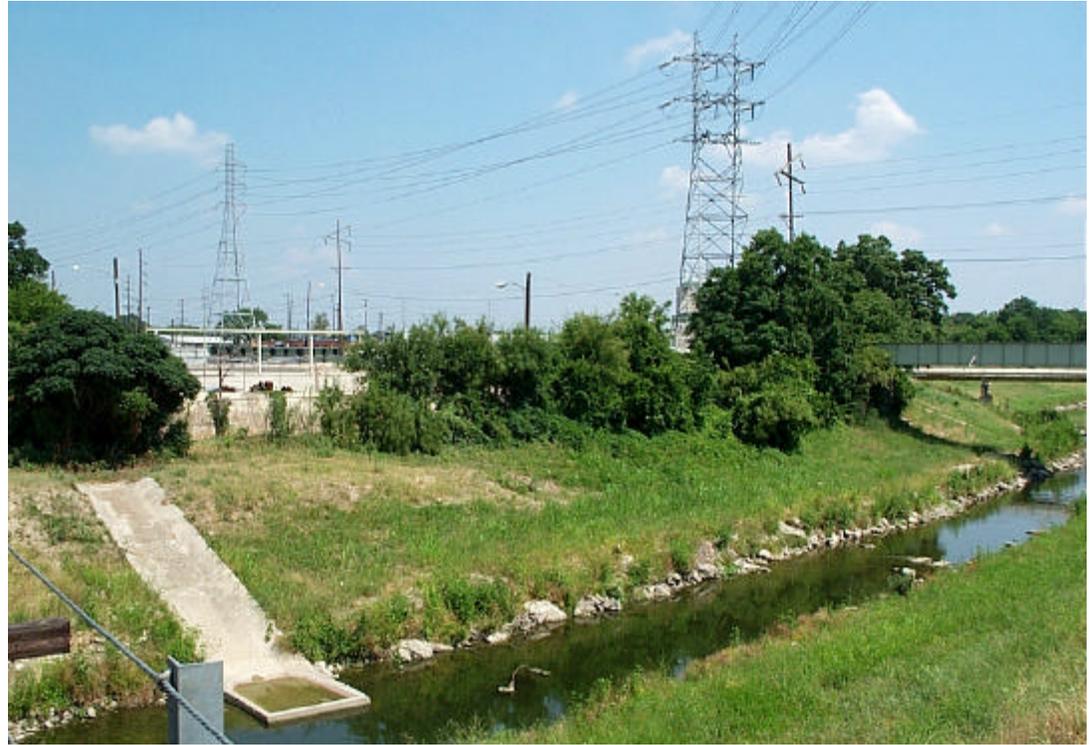
PROPERTY 28

DESCRIPTION:
View, standing on railroad bridge, towards Property 28 from the east side of the river. Property is a large San Antonio Public service power plant and storage yard.

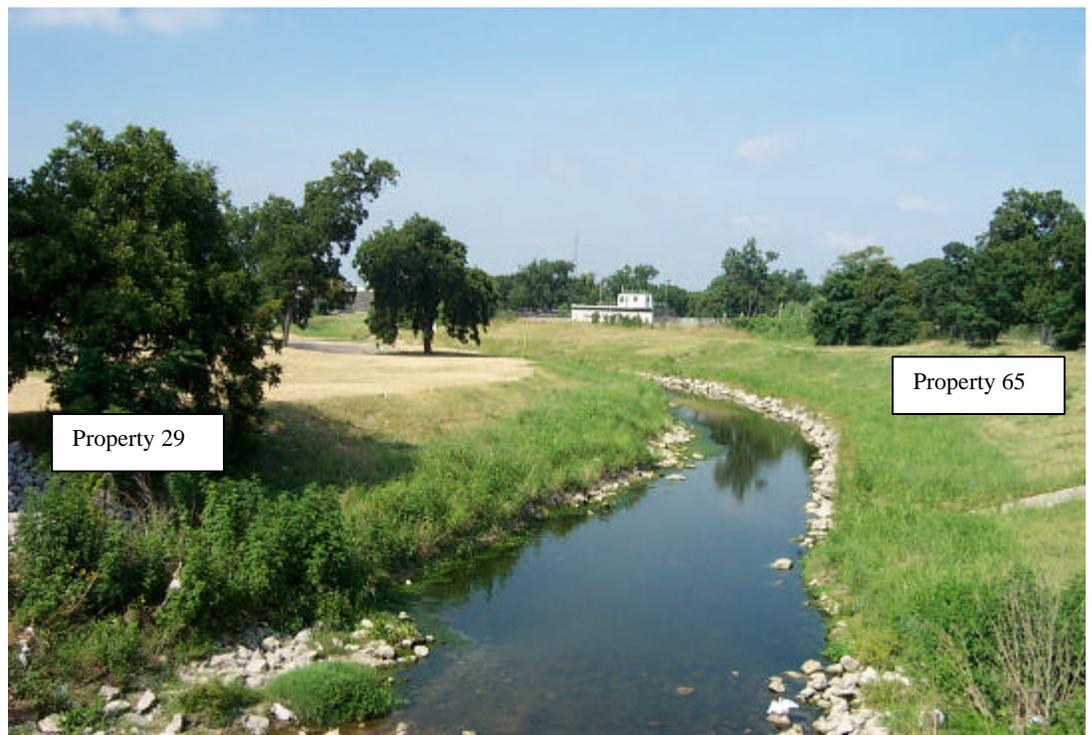
DESCRIPTION:
Roosevelt Park, Property 29, is on the left side of photo taken from Lone Star Boulevard bridge. Lone Star Brewing, Property 65, is on the right side. This location is approximately 100 feet downstream of the SARA river tunnel's outlet into the river.

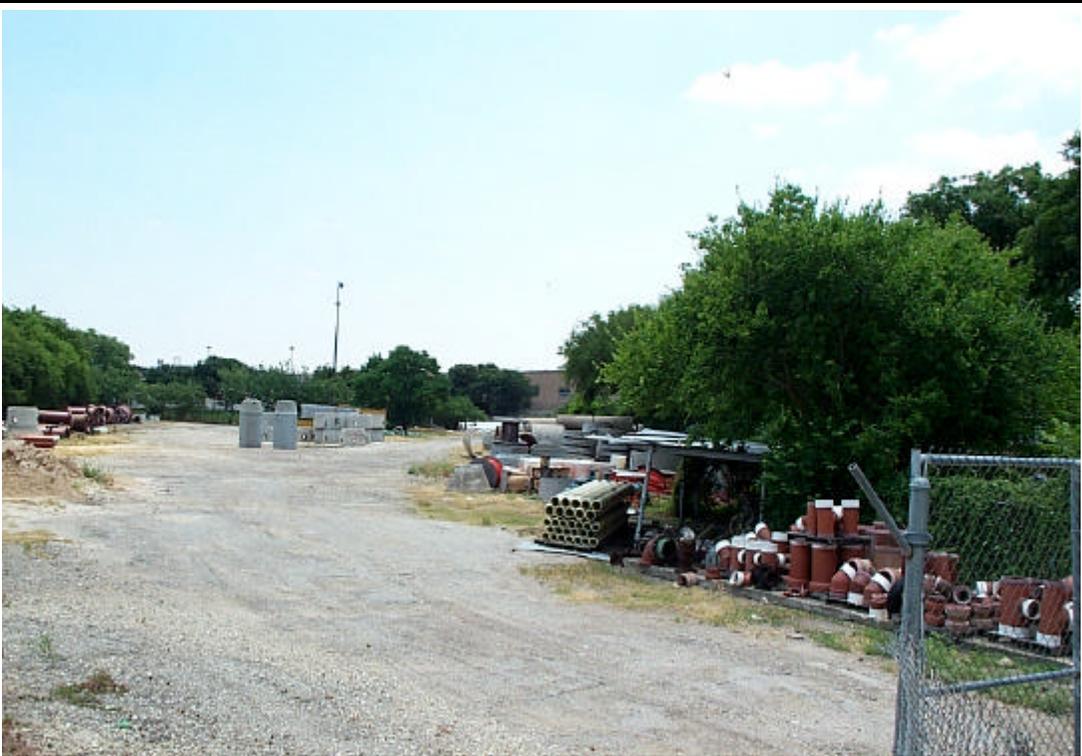
PROPERTY 30

DATE: 06/18/02	
DIRECTION: Northeast	
TAKEN BY: E. Jorgeson	
DESCRIPTION: Pipe storage lot on Property 30 just south of I-10. Building seen in background is across river on San Antonio Water Service Property 70.

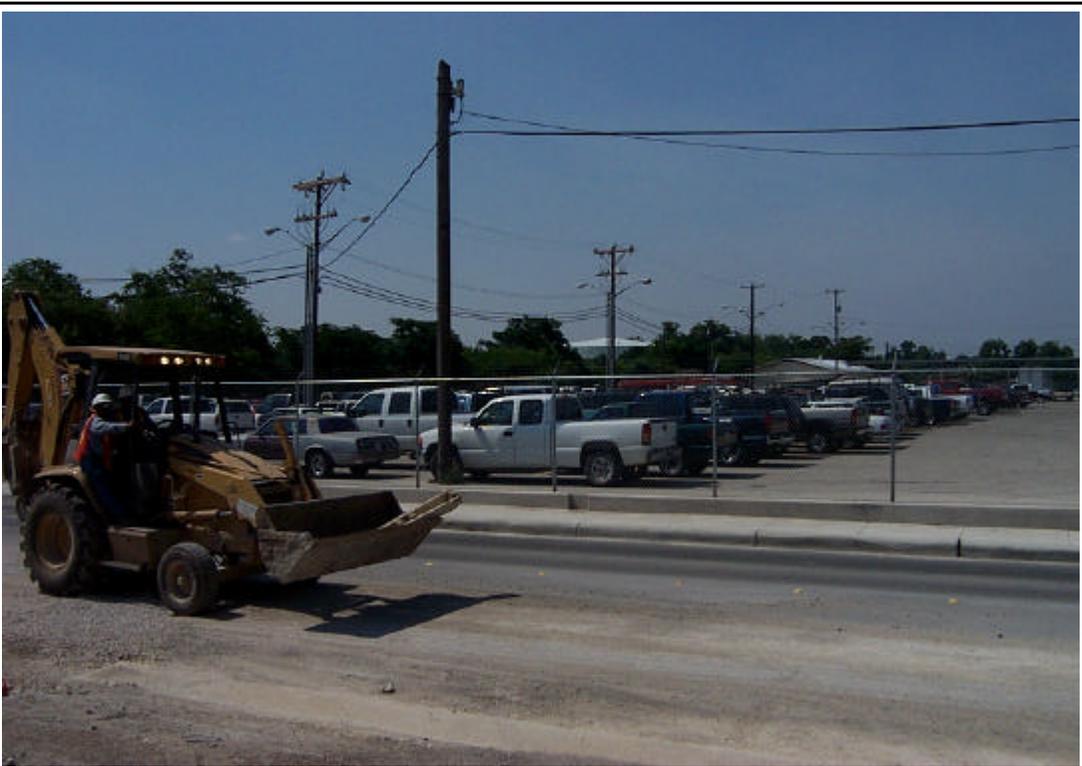
PROPERTY 31

DATE: 06/18/02	
DIRECTION: South	
TAKEN BY: M. Rahman	
DESCRIPTION: City Public Service parking lot from Mitchell Street. Extensive construction activities noted surrounding the property.

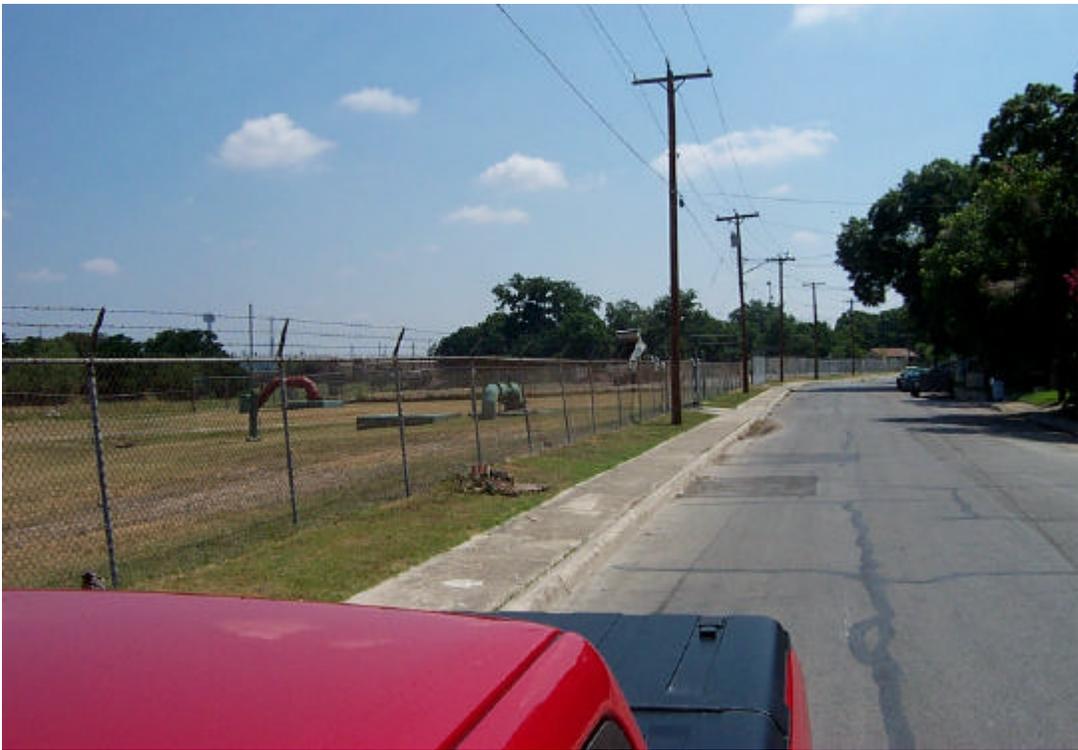
PROPERTY 32

DATE: 06/18/02	
DIRECTION: Southwest	
TAKEN BY: M. Rahman	
DESCRIPTION: Mission Pump Station associated distribution system pipes and construction activity. View from Parkview Drive.

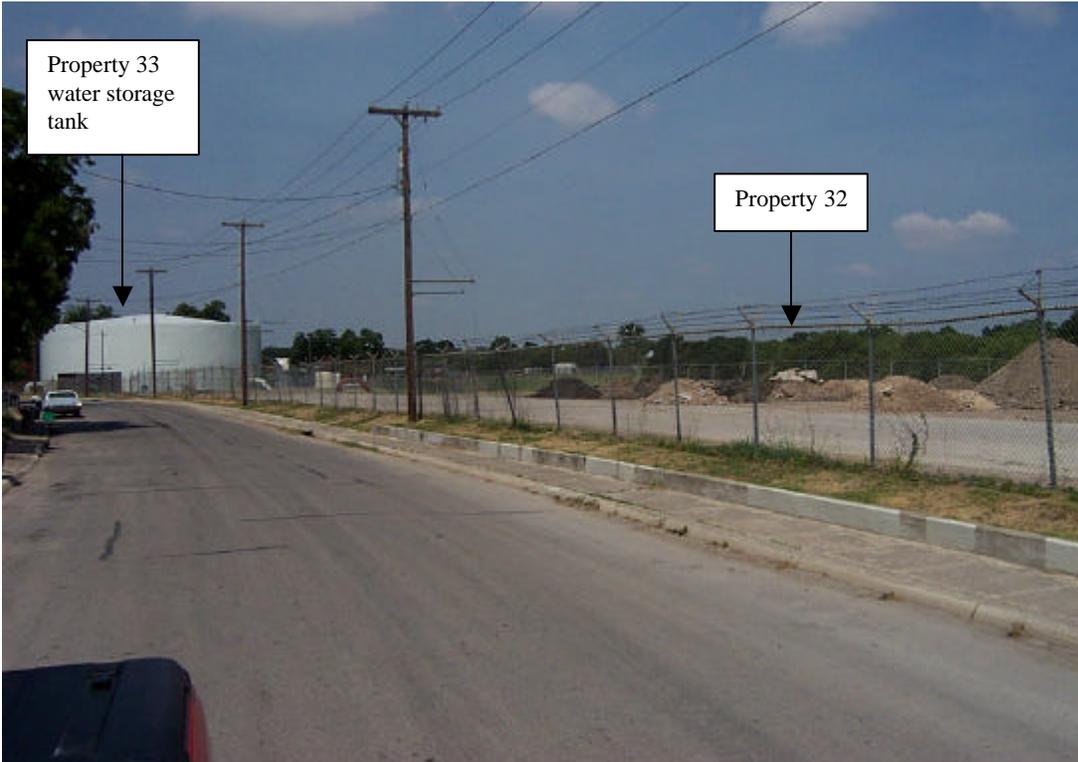
PROPERTY 33

DATE: 06/18/02	
DIRECTION: North	
TAKEN BY: M. Rahman	
DESCRIPTION: San Antonio Water Service storage tanks located north of the Mission Pump Station. View from Parkview Drive.

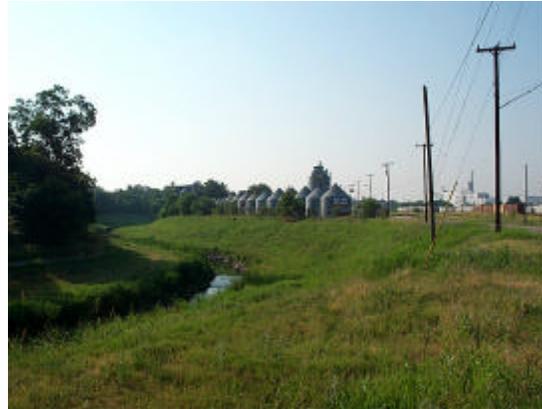
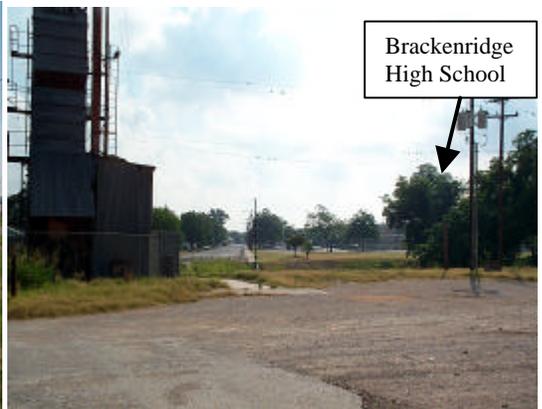
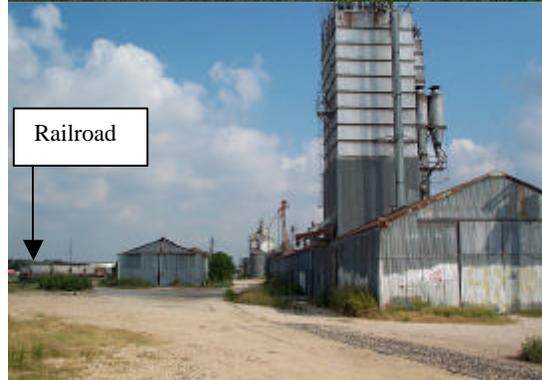
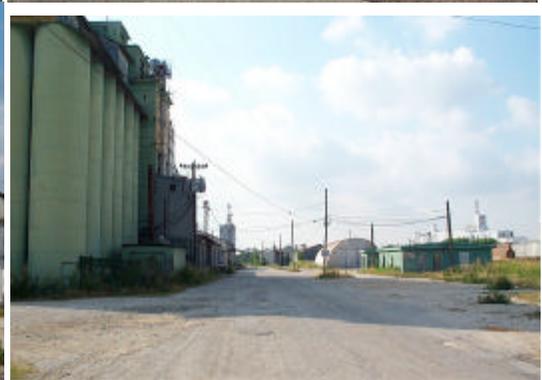
DESCRIPTION:
Big Tex Grain Company property. Railroad tracks with a parallel fiber optic line run along the west side of the properties. Upper left looking south from Blue Star Drive. Upper right looking east with river in background. Lower right looking south on Blue Star. Lower left looking north on Blue Star.

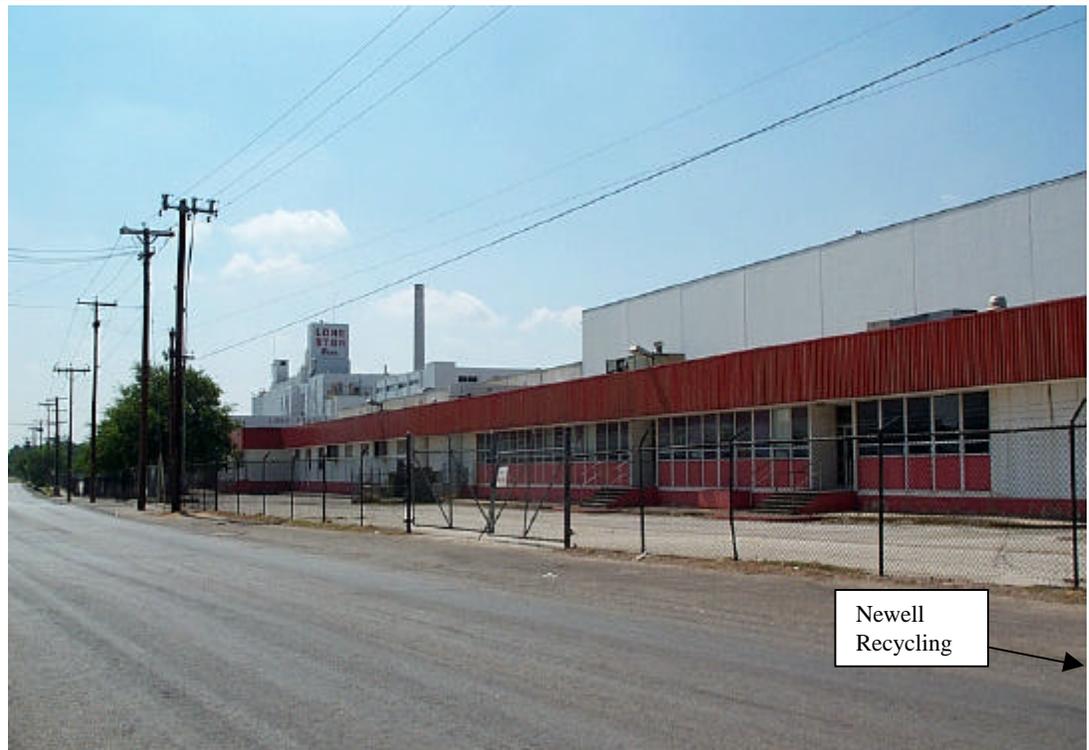
PROPERTY 65

DESCRIPTION:
View from Lone Star Drive of former Lone Star Brewery complex. Facility is currently vacant. Newell Recycling is adjacent to Property to the right of where the photo was taken.

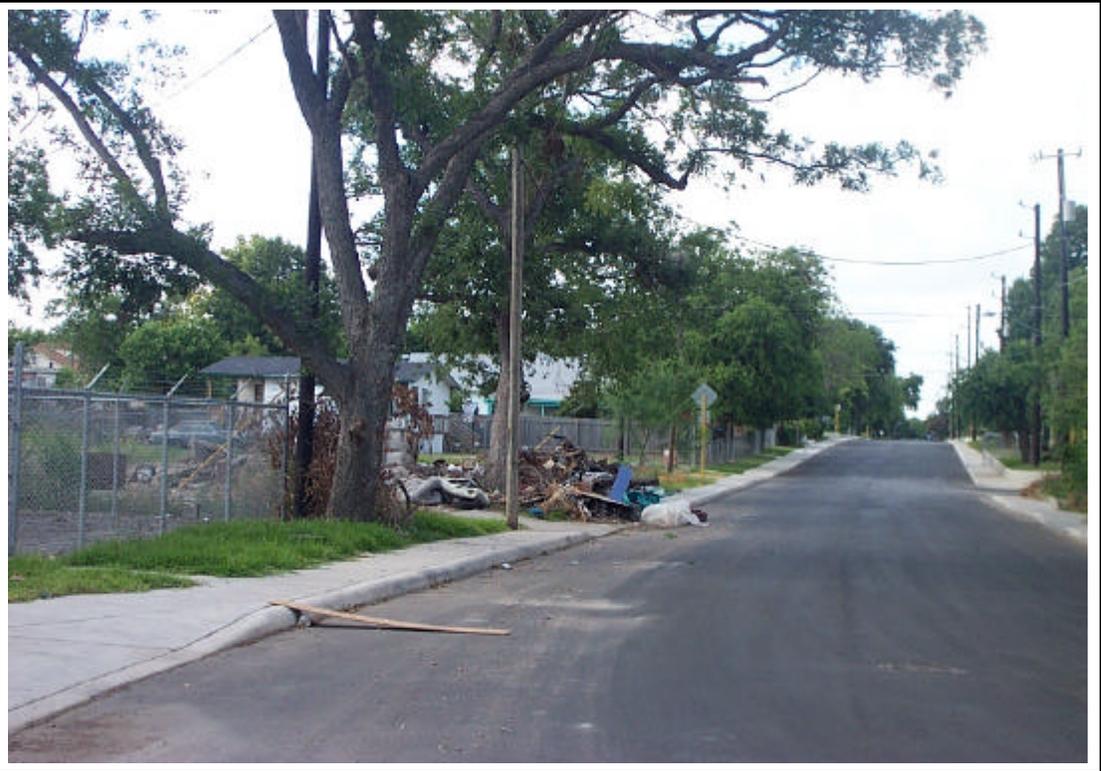
PROPERTY 67

DESCRIPTION:
Vacant lot with debris and City sewer lift station behind fence on left. View from Sierra Street.

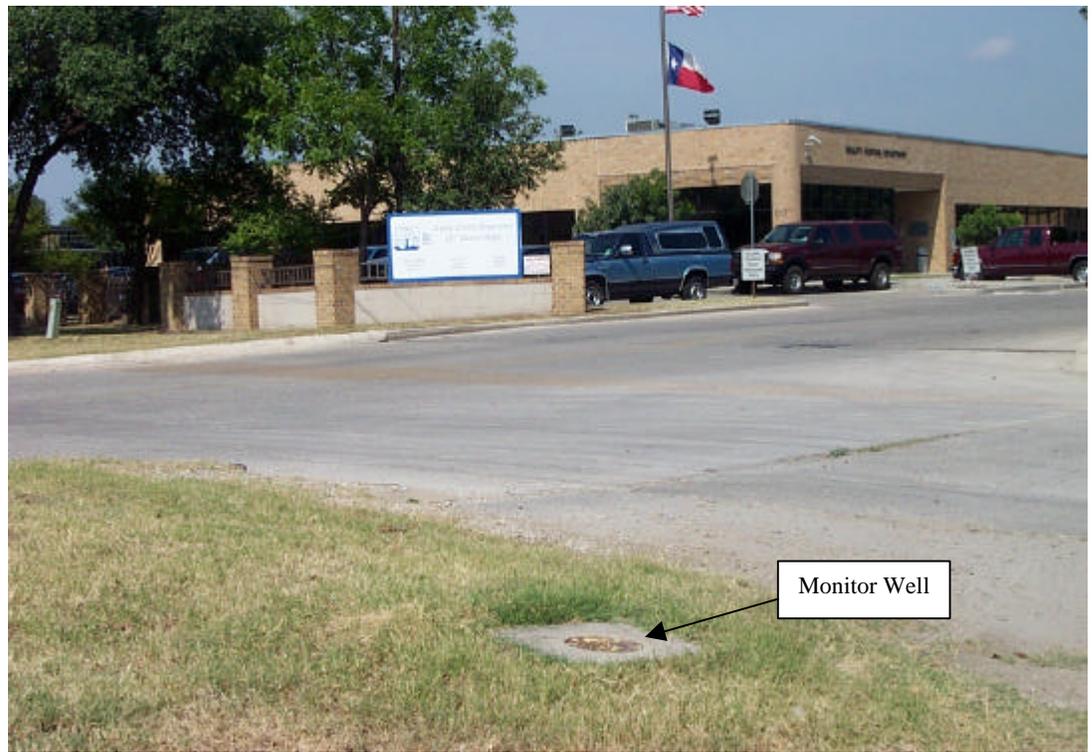
PROPERTY 70

DESCRIPTION:
San Antonio Water System. Monitor well associated with adjacent former service station is noted in photo.

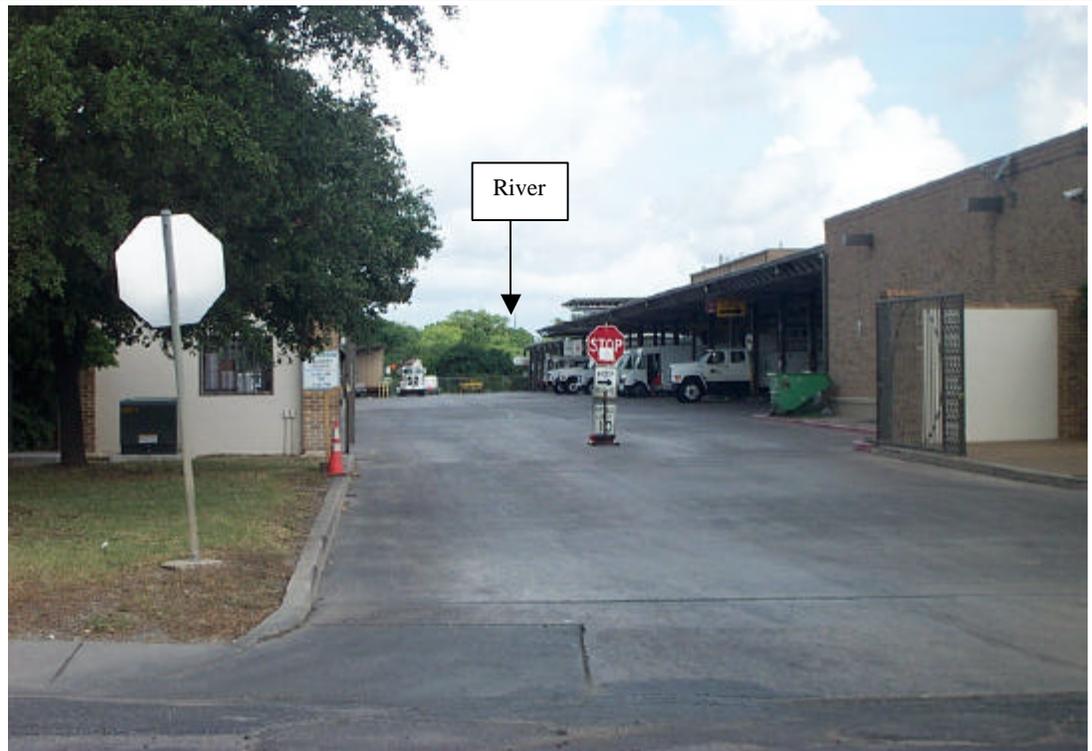
PROPERTY 71

DESCRIPTION:
San Antonio Water Service dispatch facility with active USTs and dispensers. Trees in center background are along the river. View of property taken from Mission Road.

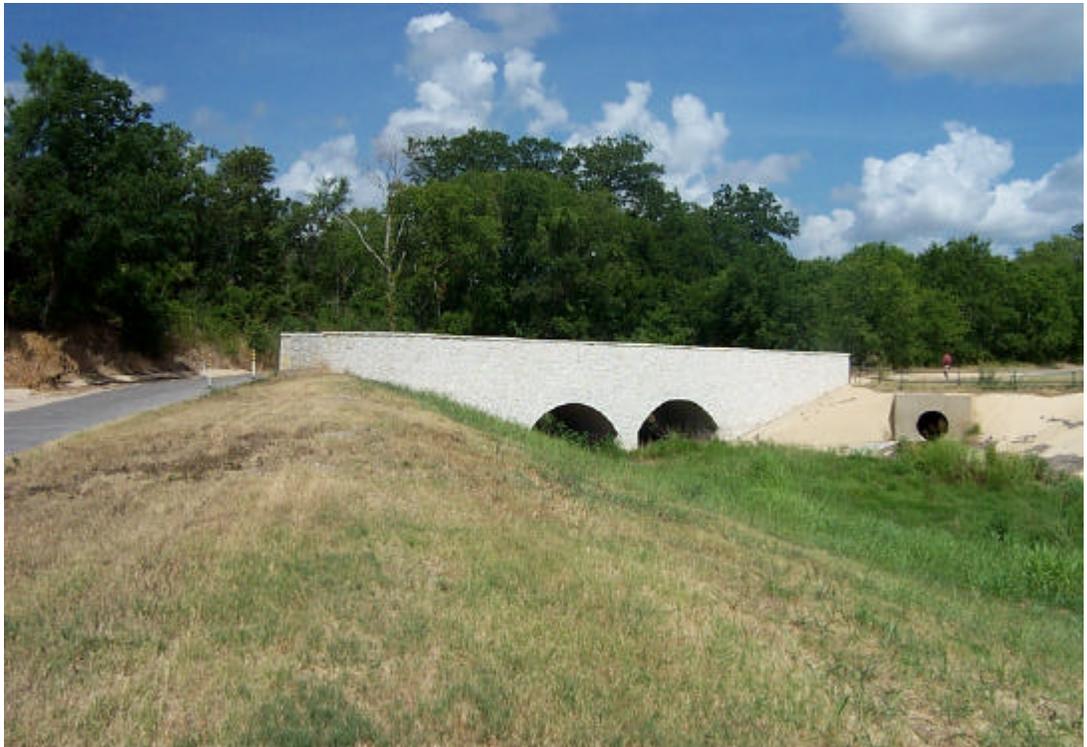
<p>PROPERTY 42</p> <p>DATE: 06/20/02</p> <p>DIRECTION: Northwest</p> <p>TAKEN BY: E. Jorgeson</p> <p>DESCRIPTION: City of San Antonio jogging path bridge over storm drain gully. Photo was taken from adjacent property 25 on the south side. Property 24 is seen on the north side of the bridge.</p>

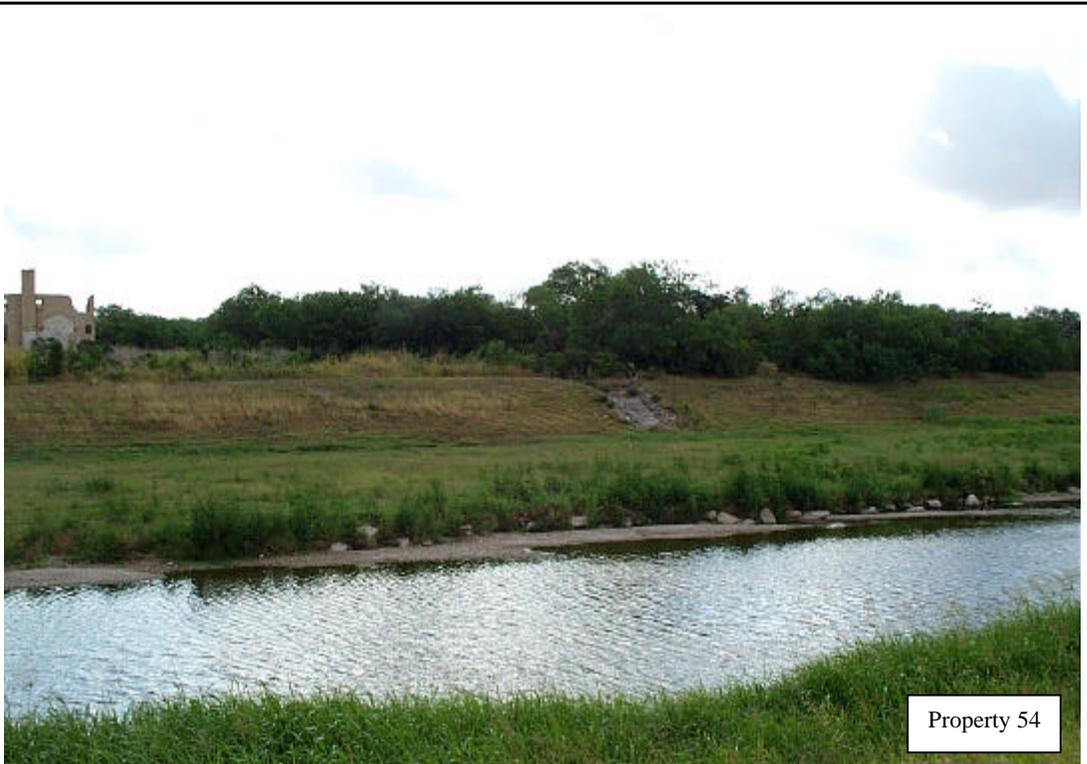
<p>PROPERTY 49</p> <p>DATE: 06/ /02</p> <p>DIRECTION: Southeast</p> <p>TAKEN BY: E. Jorgeson</p> <p>DESCRIPTION: Abandoned buildings on otherwise undeveloped wooded and grassy property accessible only from across river. Photo taken from Property 54.</p>

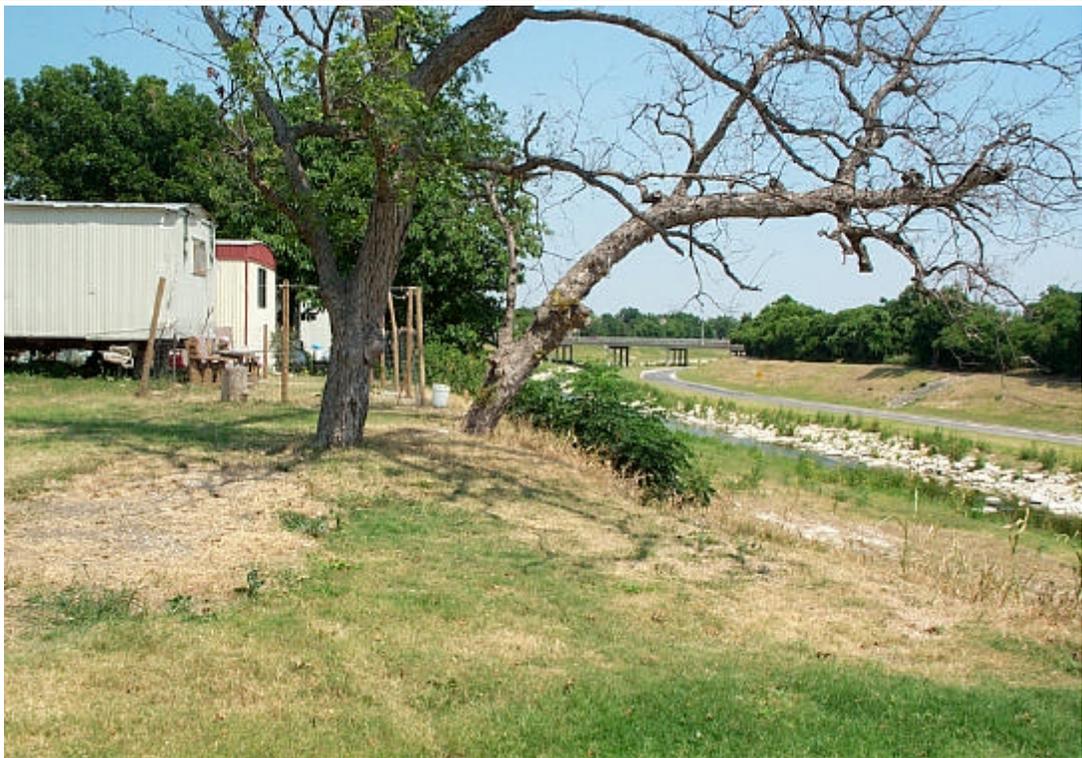
<p>A photograph of a mobil home park. A large, leafy tree is in the foreground. In the background, a bridge is visible over a river. A white mobil home is parked on the left side.</p>

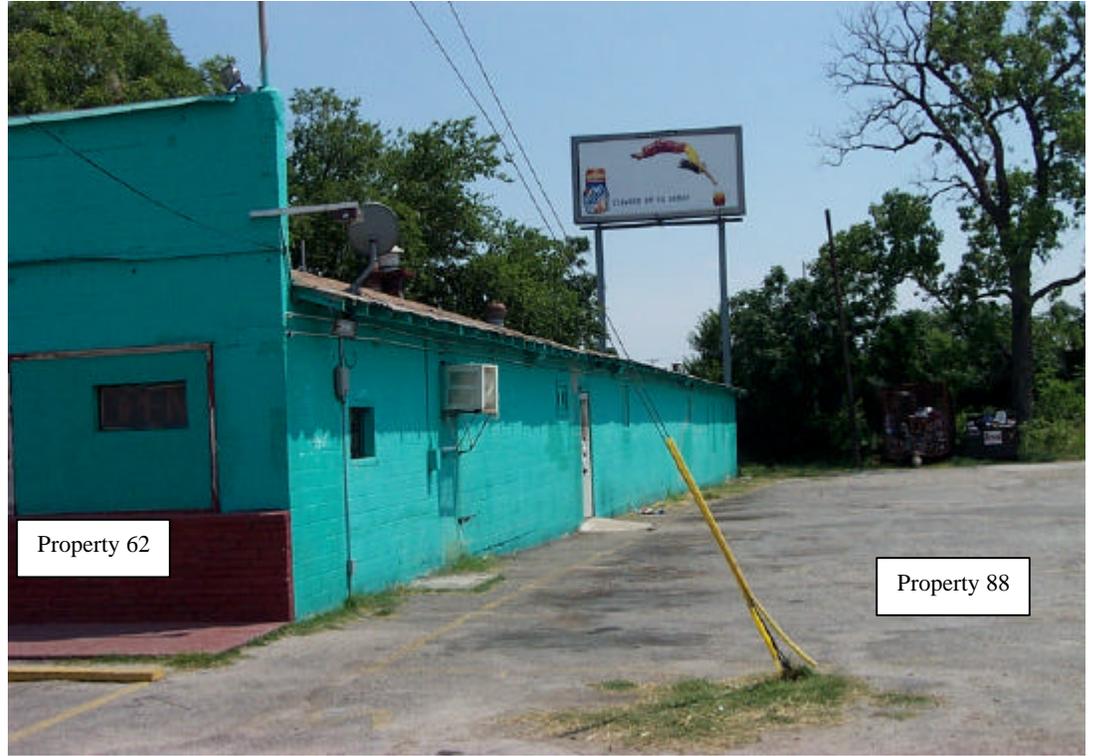
DESCRIPTION:
View from Riverside Drive of the building, property 62, and its adjacent stained parking lot, property 88, looking toward the river. Note waste dumpsters

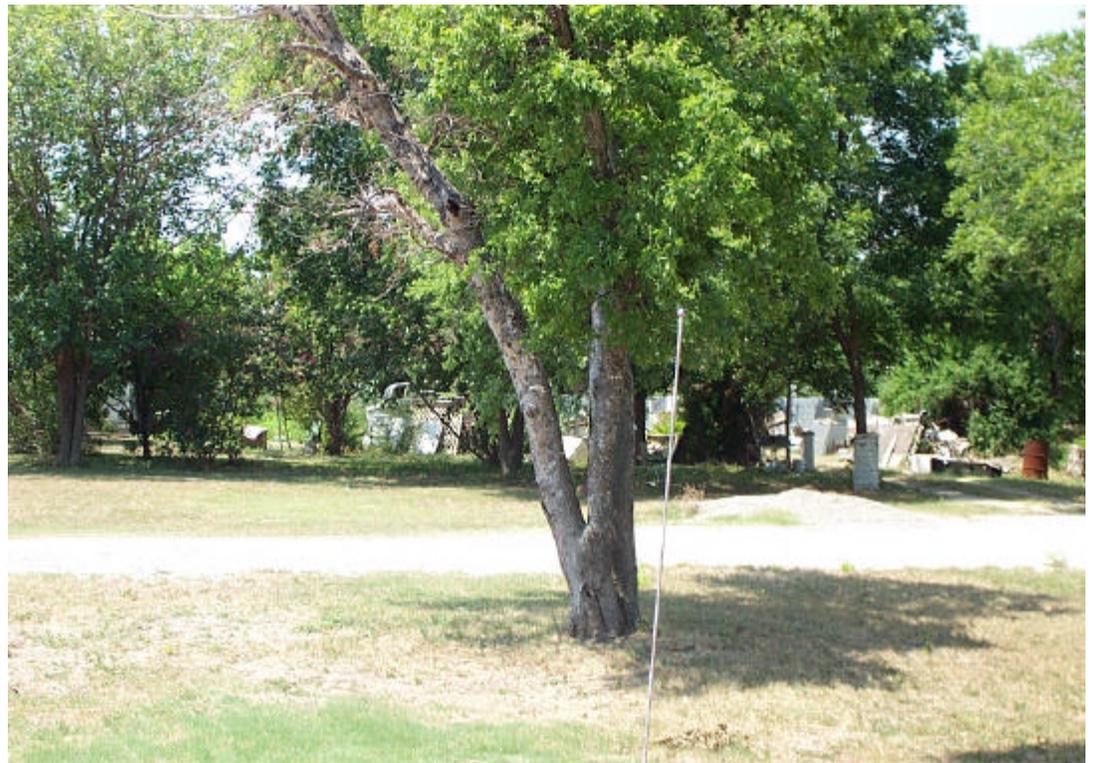
PROPERTY 64

DESCRIPTION:
Residential area with unmarked drums and construction debris.

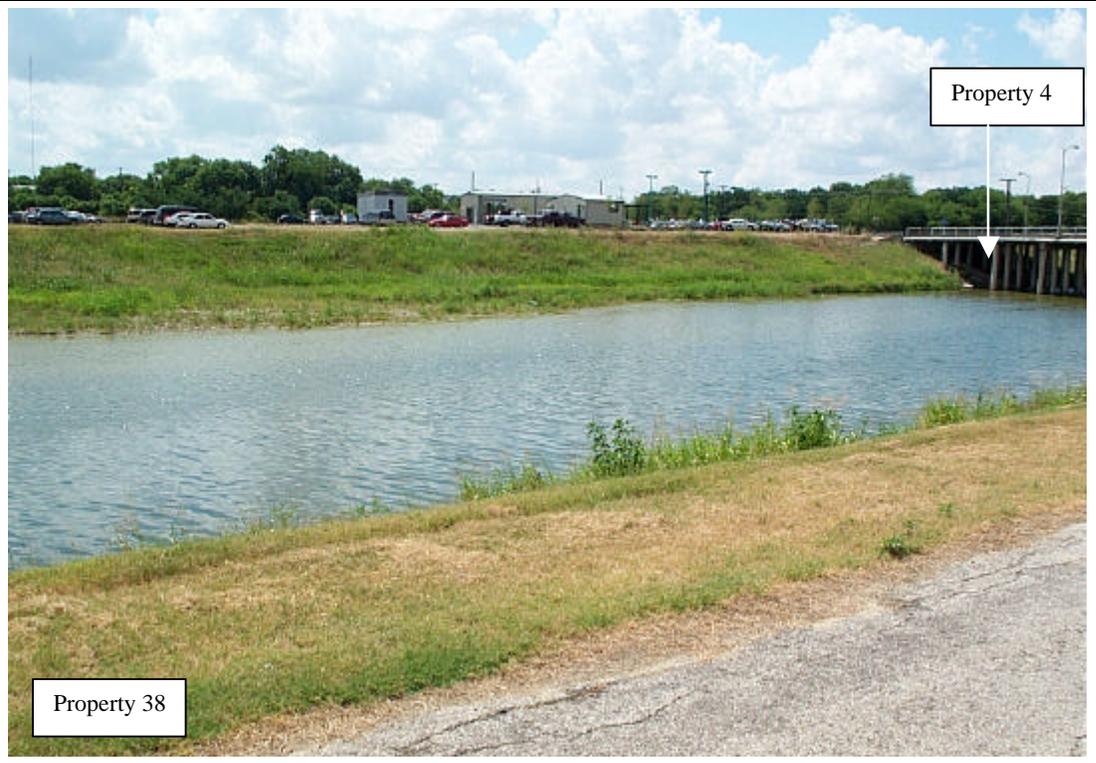
PROPERTY 68

DESCRIPTION:
Red McCombs Ford sales and car repair. Photo of Property 68 taken from property 38 jogging path. Waste oil and other drums were noted inside onsite buildings. Bridge R.O.W. at SE Military Drive is Property 4.

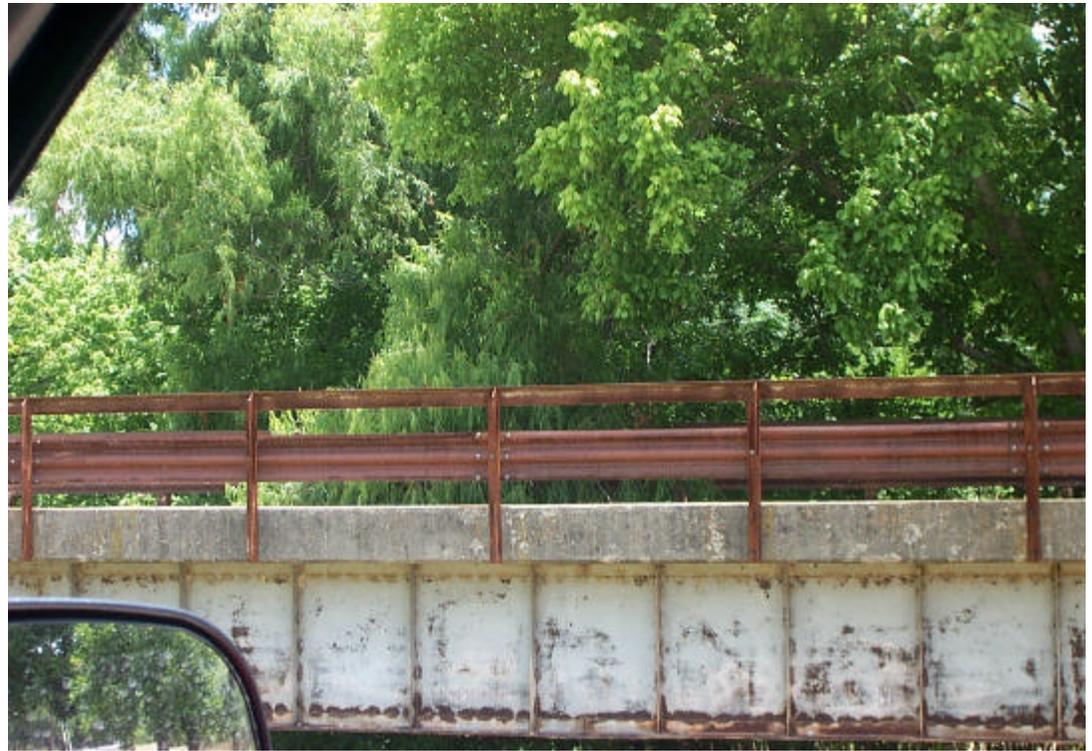
PROPERTY 81

DESCRIPTION:
Ashley Road bridge from undeveloped, wooded property 81.

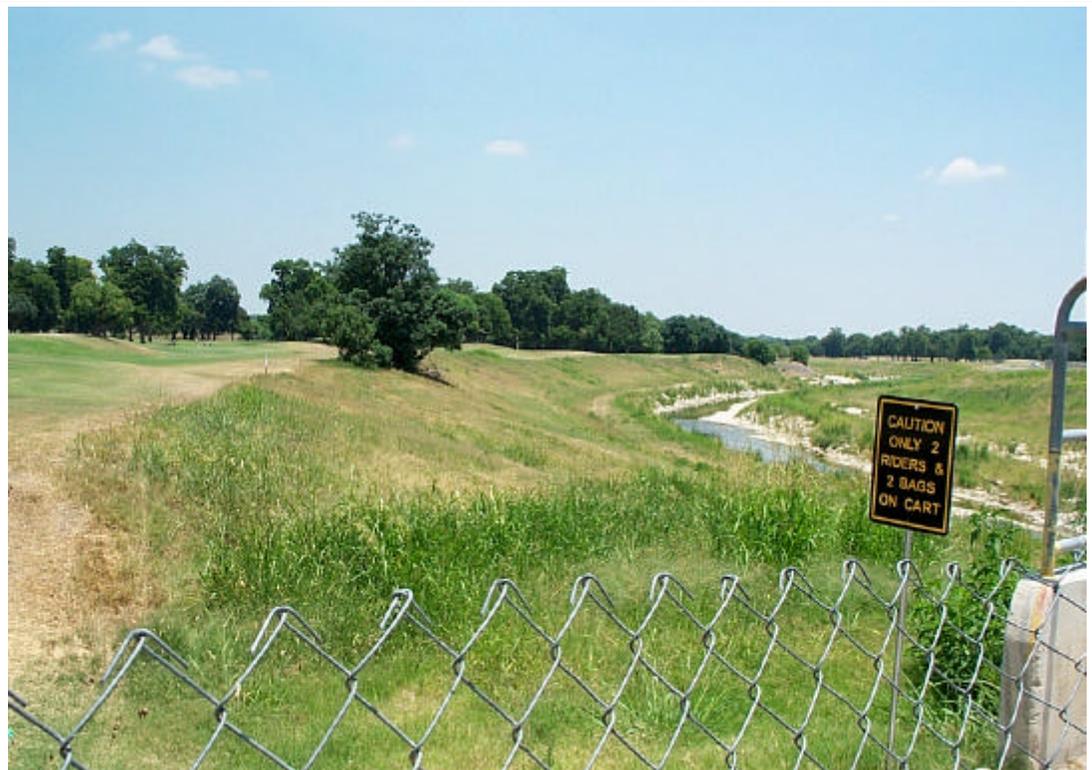
PROPERTY 87

DESCRIPTION:
Riverside Municipal Golf Course Property is located on both sides of the river. Photo taken from Mission Road bridge. Storm sewer line runs on west side of river.
