APPENDIX H
STRUCTURAL DEMOLITION LIST

STRUCTURAL DEMOLITION LIST

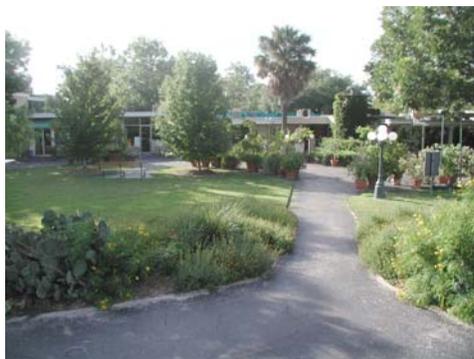
The Gift Shop

The gift shop (site map # 1) is attached to, and shares a common wall with, the two-story administrative office part (site map # 2) of this building complex. This one-story building is separated from the restaurant (site map # 3) by a covered walkway that parallels the restroom area. The building has a concrete foundation, two bathrooms, a flat roof composed of gravel over tar. The area of the building is estimated at approximately 3,780 square feet. Building and wall composition is approximately 50% brick, 30% glass, and 20% wood.

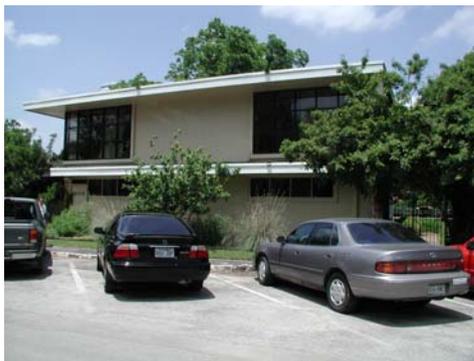
The Administration Office

The administration office (site map # 2) on the eastern end of the main complex is a two-story building that shares a common wall with the gift shop. The concrete foundation is approximately 1,620 sq. ft. The area of the building is estimated at approximately 2,970 sq. ft. There are two bathrooms, and a flat roof with gravel over tar with a 4" overhang on both stories. The walls are brick with large glass windows on the second story. Building and wall composition is approximately 65% brick, 30% glass and 5% wood.

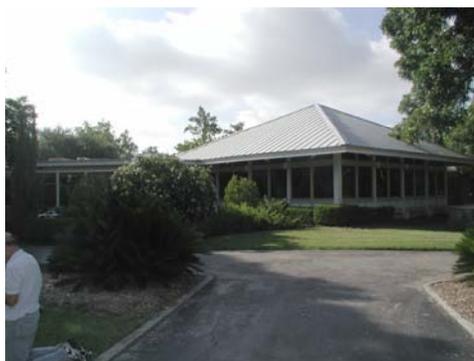
The Restaurant/(Public Restroom Area)

The large section of the main conference center building complex (site map # 3) consists of an out-of-use restaurant with kitchen, and a large public restroom area (in use). The restroom part is connected to the gift shop by a covered walkway, and has 16 stalls in the men's area and 8 stalls in the women's area. A small part of the restaurant has a flat roof with gravel over tar. The larger part has a pitched roof composed of tin. The concrete foundation is approx. 11,000 sq. ft. The area of the building is estimated at approx. 11,280 sq. ft. Building and wall composition is approx. 50% glass, 30% wood, 15% brick and stone and 5% stucco.

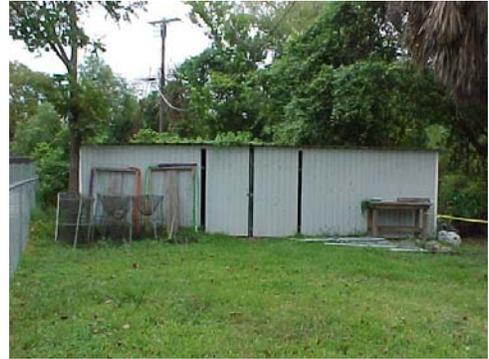
The Turtle Building (site map # 4) is a corrugated metal building located east of the boardwalk entrance and the cutter boat ramp. This building in the biology research area has a roof made of tin, and appears to have no foundation. The building is 15 ft. wide and 30 ft. long. The area of the building is approx. 450 sq. ft.

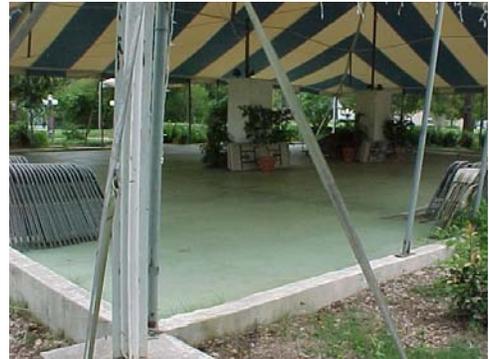
The Tent Pavilion (site map # 5) is located between The Landing and the cutter boat ramp. The structure consists of a large concrete foundation, poles and canvas. The tent part is simply a large canvas roof covering. The tent poles appear to be removable. The concrete foundation measures approximately 70 ft. wide by 85 ft. long, for a total area of approx. 5,950 sq. ft.

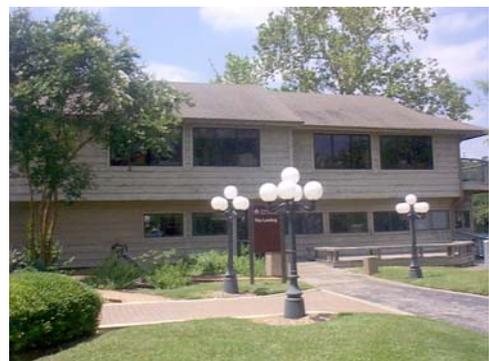
The Landing (site map # 6) is a two-story office-type wooden structure located at the edge of Spring Lake. There is a large bathroom area (6 toilets), and the pitched roof has composition shingles. The concrete foundation is estimated at approx. 1,700 sq. ft. Building and wall composition is approx. 85% wood and 15% glass. The area of the building, excluding the balcony, is estimated at approx. 3,820 sq. ft.

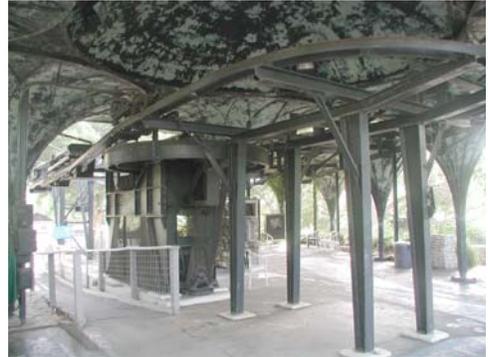
Skyline Ride Structure

Fifteen steel-reinforced concrete circular, inverted mushroom-shaped forms (site map # 7) all joined together to form a canopy over skyline ride's steel cable-works apparatus. Steel-reinforced poles support the structure. The concrete floor slab covers an area estimated at approx. 700 sq. ft. The area of the structure is estimated at approx. 675+ sq. ft.

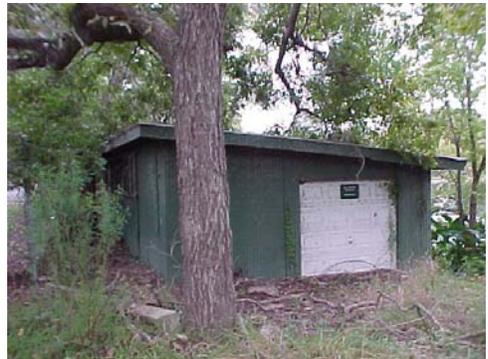
Shed (900 ft. north of Dam)

This building (site map # 30) is located on the west bank of Spring Lake, approx. 900 ft. north of Joe's Crab Shack. It is a corrugated metal building with a concrete foundation. The shed measures 20.3 ft. wide by 10 ft. high by 47.2 ft. long. The area of the building is approx. 958 sq. ft. There is good access to this site via Ed JL Green Drive.

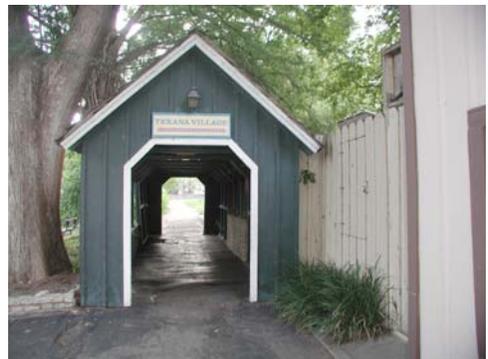
Covered Bridge

This is a rectangular wooden walk-thru covered bridge (site map # 24) located between the river and The Texana Village building. It has a wooden shingle roof, and does not have a foundation. The structure is approximately 95% wood and 5% brick. The area of the building is estimated at approx. 357 sq. ft.

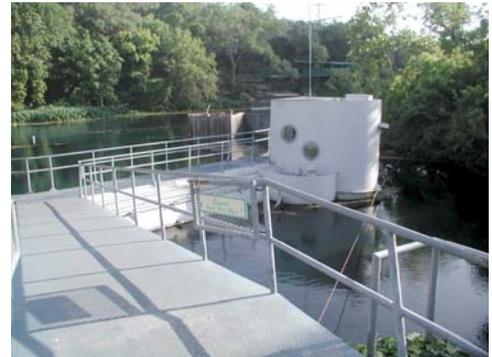
Submarine Theatre

The submarine theatre (site map # 25) is a cylindrical-shaped, tube-type structure partially submerged in the water. It is approx. 120 ft. long by 12 ft. wide by 15 ft. high. The structure is made of steel, and has a surface area estimated at approx. 1,440 sq. ft. Whether or not it had a foundation was undeterminable, due to most of the structure being underwater. It reportedly was sunk in place by filling the bottom of the steel tube (2 to 4 ft.) with many cubic yards of concrete. The submarine has elevation arms that are operational. The submarine contains two ballast tanks, a pump, and valves to pump water in and out of the submarine.

There was concern that this method would damage the lake bottom and the bank. An alternate method was devised to raise the structure from the water using a floating barge and crane and then place it onto 3 or more 8' x 40' x 5' floating barges for ballast removal and disassembly of the structure. The pieces would then be transported to the shoreline, unloaded to trucks, and

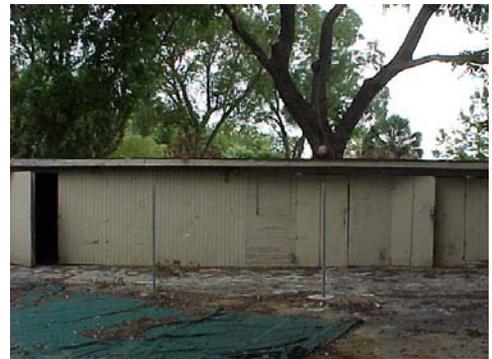
Storage Shed

This is a storage building (site map # 26) located at the rear of the Texana Village. It is a wooden structure with no foundation, and a composition-shingle roof. The building measures 45 ft. wide by 70 ft. long by 8 ft. high. The area of the building is approx. 3,150 sq. ft.

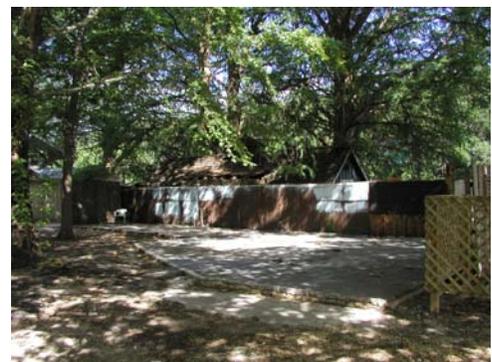
Texana Village Building Foundation

This was a wooden building (site map # 13) located next to the Covered Bridge structure. The building has already been demolished by SWT. The storage-type building has a concrete foundation. The area of the concrete foundation is estimated at 1,381 sq. ft.

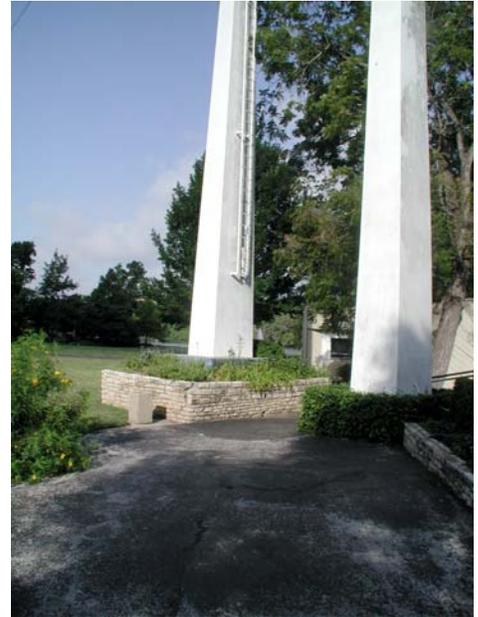
Skyline Tower # 15A (on the grounds)

There are two steel tower structures (site map # 15A & # 15B) on the grounds that support the shutdown sky ride. The towers are near the submarine theatre, and are situated within approx. 10 ft. of each other. Both towers are made of welded steel. Attached to each tower are two 1" steel cables and two small electrical cables. Both towers taper down to an estimated half-size before they reach the top. Depth and size of the structures below ground were not determined. Tower #1 (site map # 15A) is 75 ft. tall from ground level. The base of the steel tower itself measures 4.3' by 3.1'. The visible bottom concrete base is 6' by 7' by 4'(H).

The second tower (site map #15 B) is 75 ft. tall from ground level. It has a visible concrete base of 6' by 7' by 2.2' (H). The base of the steel tower itself is 3.2' by 4.4'.

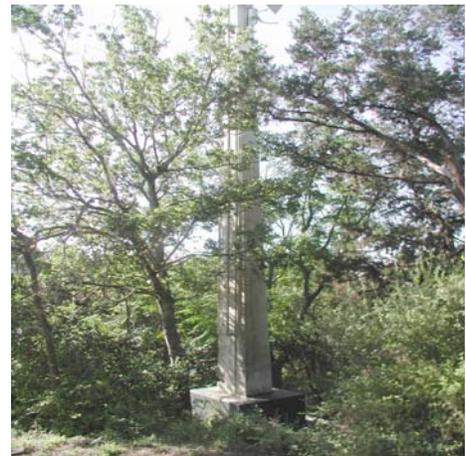
Skyline Tower # 16A (on the hill)

There are two steel tower structures (site map # 16A & # 16B) on the hill that support the shutdown sky ride. These two towers are on the west side of Spring Lake. Both towers are made of welded steel. The tower rises approx. 48 ft. above the concrete. Attached to each tower are two 1" steel cables and two small electrical cables. Both towers taper down to an estimated half-size before they reach the top. The base of the steel tower itself measures 3.1' by 2.1'. The lower concrete base is 14.1' by 9' by 3' (avg. H). The upper concrete base is 6' by 5.3' by 2.8' (H).

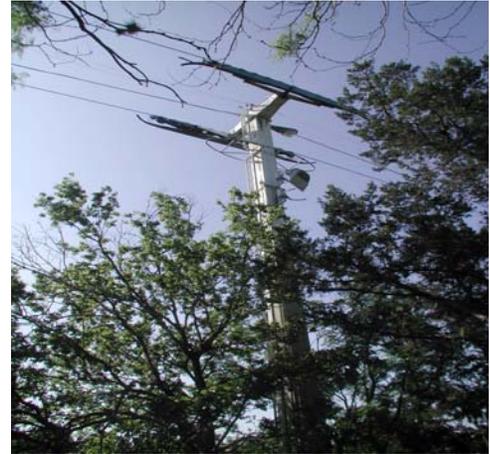
Skyline Tower # 16B (on the hill)

Skyline Tower # 16B is located approx. 90' further up the hill from Tower # 16A. It rises approx. 40 ft. above the concrete. The base of the steel tower itself measures 2.9' by 1.65'. The lower concrete base is 14.1' by 10' by 2' (H). The upper concrete base is 6' by 5.3' by 2.8' (H).

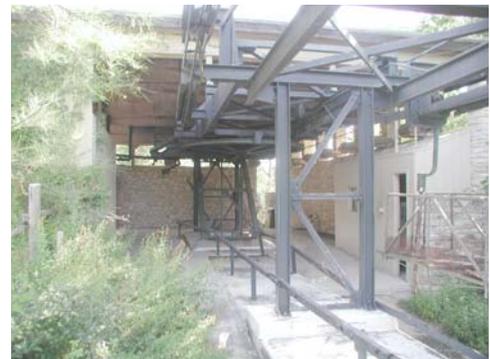
Skyline Ride Structure (on the hill)

The skyline ride structure (site map # 19) houses the end of the skyline ride on the hill. It has an approximate area of 2,244 sq. ft. The building consists of one open end, with 3 stonewalls. The stonewalls are 1.4' (W) by 9.3' (H), for a total length of 119'. The concrete foundation measures 68' by 33'. There is a flat wooden roof with tin on top. The bolted steel lift structure covers an area approx. 63' by 11'. An elaborate fence is outside the building composed of wrought iron and stone columns. The stone columns measure 1.4' (W) by 6' (H), with 3 corner stone squares. There is approx. 56' of fence.

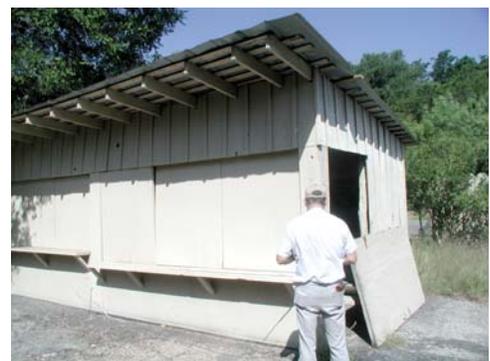
Vendor Building

The vendor building (site map # 19A) is on the hill near the northern skyline ride structure. It is a wooden building with no foundation. It measures approx. 23.3' (L) by 10.6' (W). It has a tin roof.

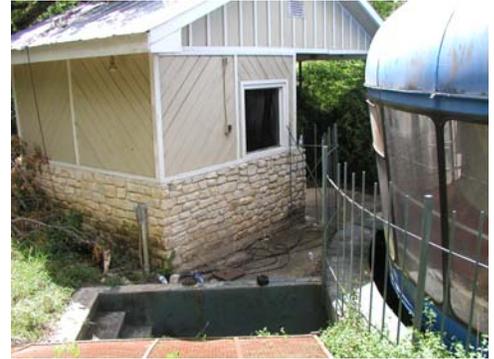
Observation Tower Ticket Booth

The observation tower ticket booth (site map # 42) is located on the hill adjacent to the observation tower. It has a concrete foundation and a tin roof. The building is approx. 50% wood, 30% stone, and 20% glass. It measures approx. 12' (W) by 10' (L) by 8.8' (H). It has a pitched roof approx. 4.2' in height.

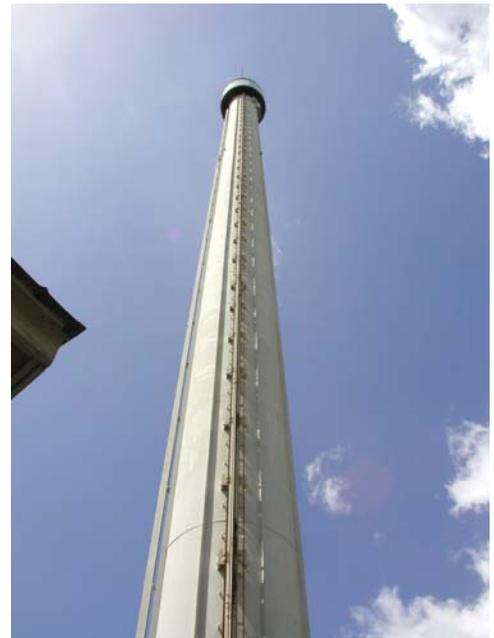
Observation Tower

On the hill is the observation tower (site map # 42a.). The tower consists of a steel tower, a doughnut-shaped observation ring, and an operations basement. The steel tower is approx. 185' in height, has a diameter of 6.5', and the estimated thickness of the steel is 1". The ring is a seating carriage approx. 10' in height, with a diameter of approx. 30.5'. The circumference of the observation ring is approx. 85'. The basement foundation houses electric motors and hydraulic operational controls. The concrete basement is approx. 30.5' (L) by 30.5' (W) by 6.5' (H). It could not be determined how deep the concrete was below ground.

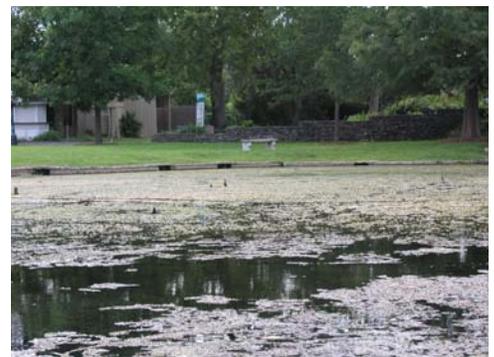
Fountain Structure

The fountain structure (site map # 43) consists of a piping system previously used for a water fountain in the lake. There are approximately 12 pipes from the shoreline stonework structure to the fountain structure. The piping system and the fountain are located in a shallow area of the lake, approx. 1' to 4' deep. The piping may be 2" diameter metal.

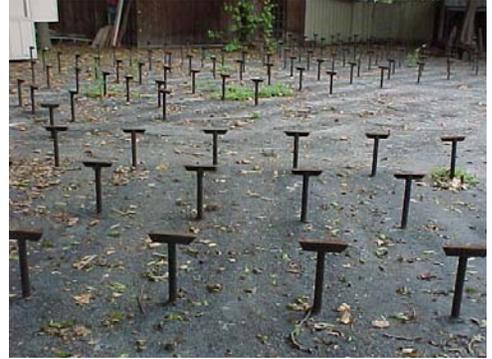
Benches Area (Asphalt)

Site Map Bldgs. # 11, # 12 and # 14, border the open seating area of The Texana Village (site map # 11A). It contains metal supports that were previously used for 34 wooden benches. The open area is estimated at approx. 725 sq. ft., and is approx. 85% covered with asphalt.

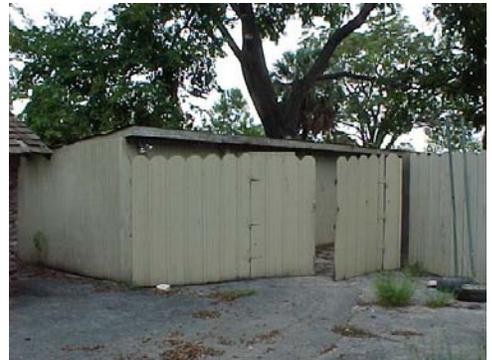
Fences

The project area contains many segments of wooden fences. All fences were made of 1" thick material, with about three 2" by 6" braces. There are approximately: 80 ft. of 10 ft. high, 375 ft. of 8 ft. high, 125 ft. of 7 ft. high, and 55 ft. of 6 ft. high fences. Note: allow at least 25% for missed wooden fences, because there were too many to be extremely accurate.

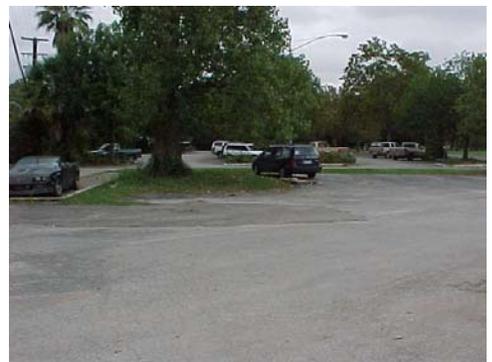
Parking Lot

The parking lot (site map # 27) at the project area has 6" curbs and gutters. Their total length is estimated at approx. 4,660 ft. The total area of the parking lot is estimated at approx. 75,250 sq. ft. The total volume of parking lot asphalt to be removed is estimated at approx. 929 cubic yards.

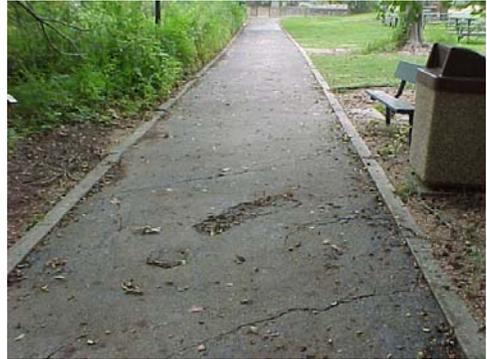
Sidewalks

The project area contains many segments of connecting sidewalks. Some are concrete and some are asphalt. The total area covered by sidewalks is estimated at approx. 62,572 sq. ft. The total volume of the sidewalks is estimated at approx. 676 cubic yards.

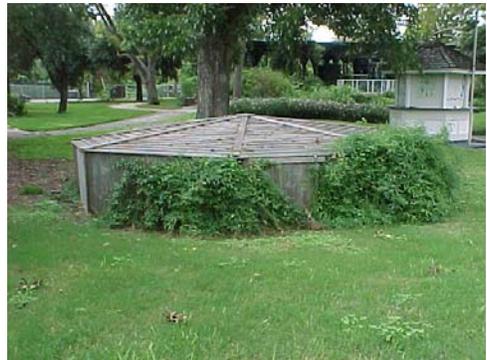
Octagonal Structure

Outside building # 3 (Restaurant/Public Restrooms on the site map) is an octagonal-shaped wooden structure (site map # 17). It measures 7.3' by 8' by 3.3' (H), with a 4' high center.

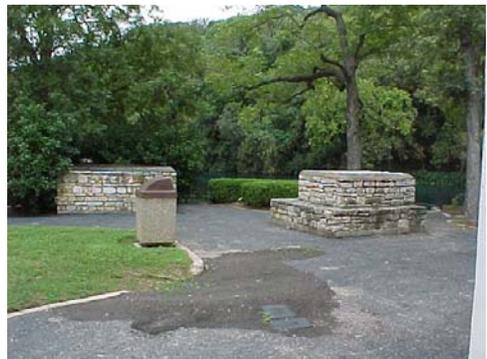
Stone Pump Houses

In front of the Diver's Locker (site map # 8) are two small stone square pump houses (site map # 18). One stone structure measures approx. 10' by 11' by 3.6' (H). The other stone structure measures approx. 8' by 8' by 4' (H), with an upper inset area measuring approx. 6.11' by 5.3'.

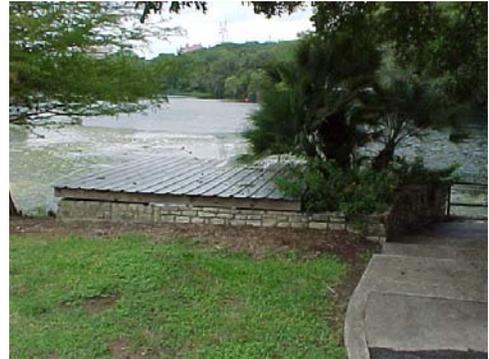
Stonework Structure

On the south side of the Diver's Locker building (site map # 8) is a stonework structure (site map # 23) near the water's edge. The stone structure measures approx. 16' (L) by 12' (W) by 3.3' (H). It has a flat tin roof. It has a concrete slab foundation measuring 16' by 12'.

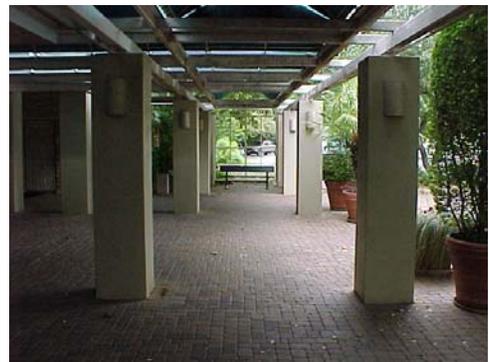
Concrete Columns

At the entrance of the gift shop (site map # 1) there are 16 concrete columns (site map # 20). They each measure 1.65' by 1.65' by 8.2'(H).

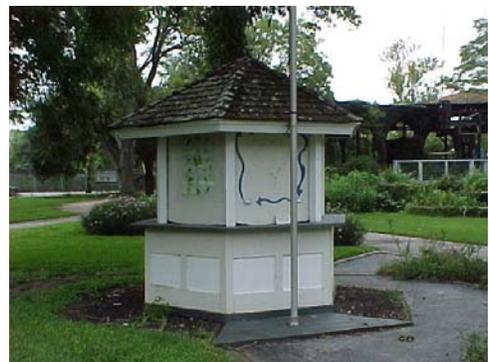
Ticket Booth

The ticket booth (site map # 21) is located near building # 3. It is a small 6-sided wooden structure. Each side appears to be approx. 5.6' (W) by 9' (H). The booth appears to have a 4-sided 3' (H) pitched composition shingle roof. The structure appears to have no foundation.

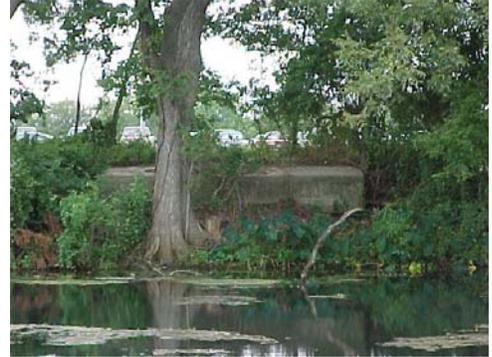
Concrete Debris

Concrete debris (site map # 33) is located on the east bank of the slew, across from the boardwalk. There are 4 concrete slabs in this area totaling a surface area of approx. 469 sq. ft. The largest concrete slab is approx. 2.6' (H) by 18.2' (W) by 15.7' (L). One concrete slab is 2' (H) by 6' (W) by 3.10' (L). A third rectangular slab is 1' (H) by 10.7' (W) by 8.6' (L). The fourth slab is circular in shape, with a height of 2.6', and a diameter of 8.5'

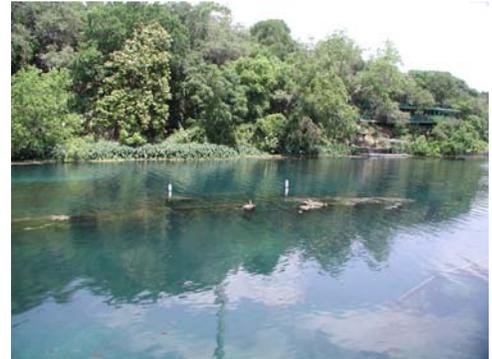
Sunken Structure

Located below water in Spring Lake to the west of the submarine theatre lies a sunken structure (site map # 29). The submerged structure, which consists of metal and concrete, is full of water and rests on the lake bottom. SWT says that the structure is smaller than the submarine theatre. Dimensions are estimated at 80' (L) by 10' (W) by 13' (H).

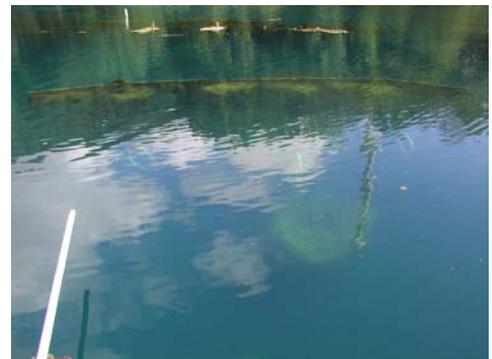
Miscellaneous Sunken Material

Located below water to the south of the sunken structure lies some miscellaneous sunken material, (site map # 44). The sunken material includes a volcano structure, lily pads, and other diver training structures. The volcano structure is a metal wall, with estimated dimensions of 50' (L) by 8' (W) by 15' (H). The concrete lily pads are approx. 8' in diameter, with a 2' thickness.

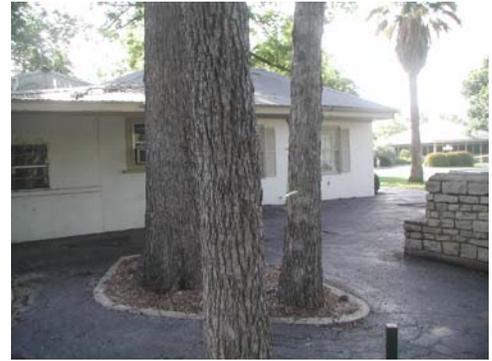
Steel Tank

There is a steel tank (site map # 45) located behind the Diver's Locker building. The tank is on legs, and it is approx. 14' in length. It has a diameter of 5'. Shown in the photo is the building that stands adjacent to the steel tank. The tank is located on the north side of the building.

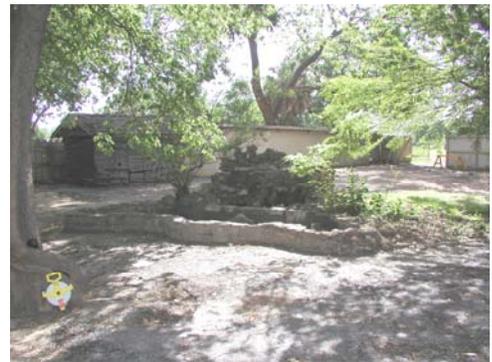
Concrete Debris in Texana Village Area

In the Texana Village area there is some concrete debris (site map # 46) that was previously used for a small pond and waterfall display. It consists of a concrete pond area, and a concrete mound area. The concrete mound area is approx. 12.3' (W) by 9.8' (L) by 4' (H). The concrete pond debris is elliptical-shaped with a height of 1.3', and concrete 1' thick. It is contained in an area approx. 22.5' (W) by 9.5' (L).

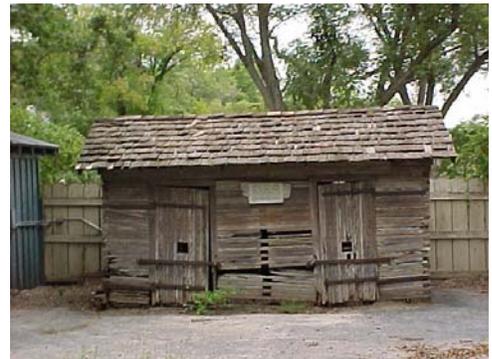
According to our information, SWT will coordinate the relocation of the Kyle City Jail and Equipment Shack. The Kyle City Jail (site map # 22) is a historically significant structure located within The Texana Village.

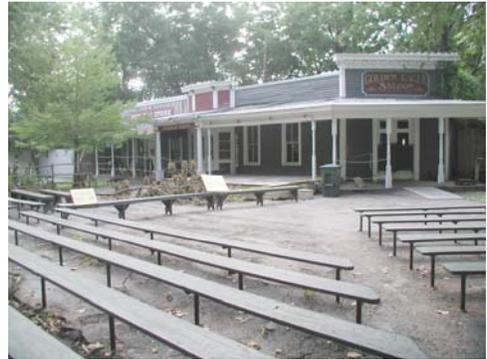
Saloon/Barbershop/General Store

This was a wooden replica of turn-of-the-century architecture in The Texana Village area (site map # 11). The rectangular-shaped building housed replicas of a saloon, barbershop, and a general store. It had a roof of flat tin over wood, and a wooden foundation of approx. 1,815 sq. ft. The area of the building was approx. 1,815 sq. ft., and is composed of 90% wood, and 10% glass.

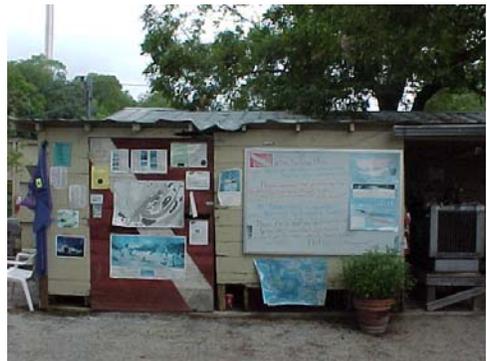
The Equipment Shack (site map # 9A) is a storage building that sits behind the Diver's Locker building.

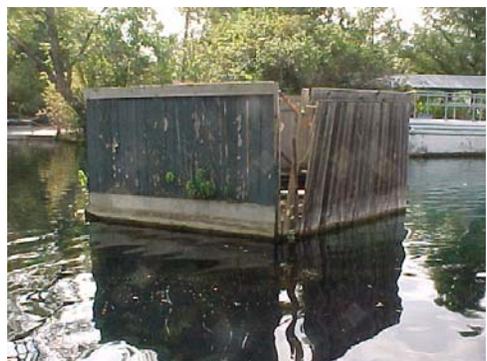
The Salamander Sampling Site (site map # 34) sits in the water in Spring Lake in an environmentally sensitive area. SWT and the U.S. Fish & Wildlife Service will coordinate the repair and replacement of the Salamander Sampling Site.

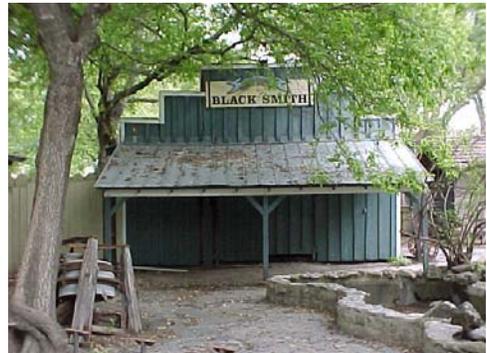
Blacksmith Shop

This is a wooden replica of a blacksmith shop (site map # 12) in The Texana Village Area. It has no foundation and a tin roof. The area of the building is approx. 434 sq. ft.
